Final Archaeological Excavation Report

# Cullenagh More

Co. Galway

Lime Kiln

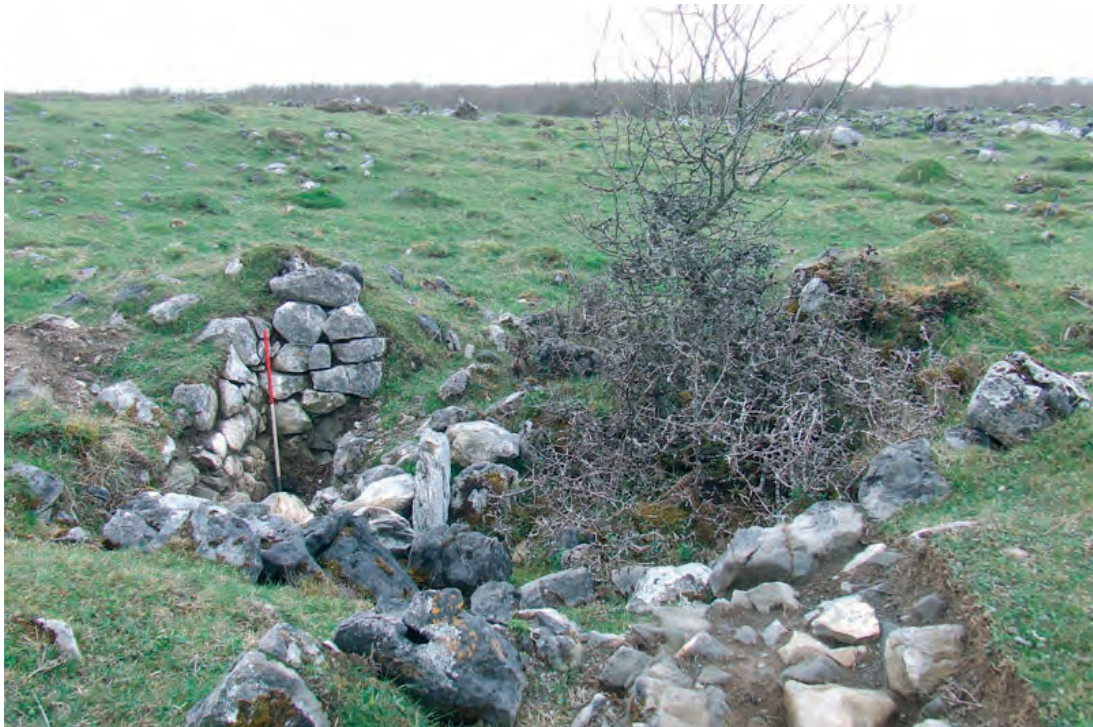
Plate 1: Pre-excitation photograph of sunken chamber.

The structure comprised a roughly square, earth-dug, subterranean chamber, revetted with coursed random rubblestone with small angular pinnings (Plate 1). Small mounds of lime were discovered in the corners and along the floor edges. The floor is now irregularly stepped and slightly sloping limestone bedrock. However, it seems that this may have been levelled using a thin layer of gravel and grit and small flat 'flagstones', a small number of which survive *in situ*. At the base of each wall near the centre point is a small lintelled flue. The opening in the north wall was slightly larger and of different construction to the other three flues. The upper courses appear to have been rebuilt at some point and now protrude slightly from the ground surface. The exterior of the upper part of the wall is revetted with a low roughly circular 'cairn' of earth and stone now covered in a thin layer of sod and moss. The interior was filled with large limestone slabs and boulders, rubblestone and earth. A large hawthorn tree and off-shoots were embedded in the northeast corner.

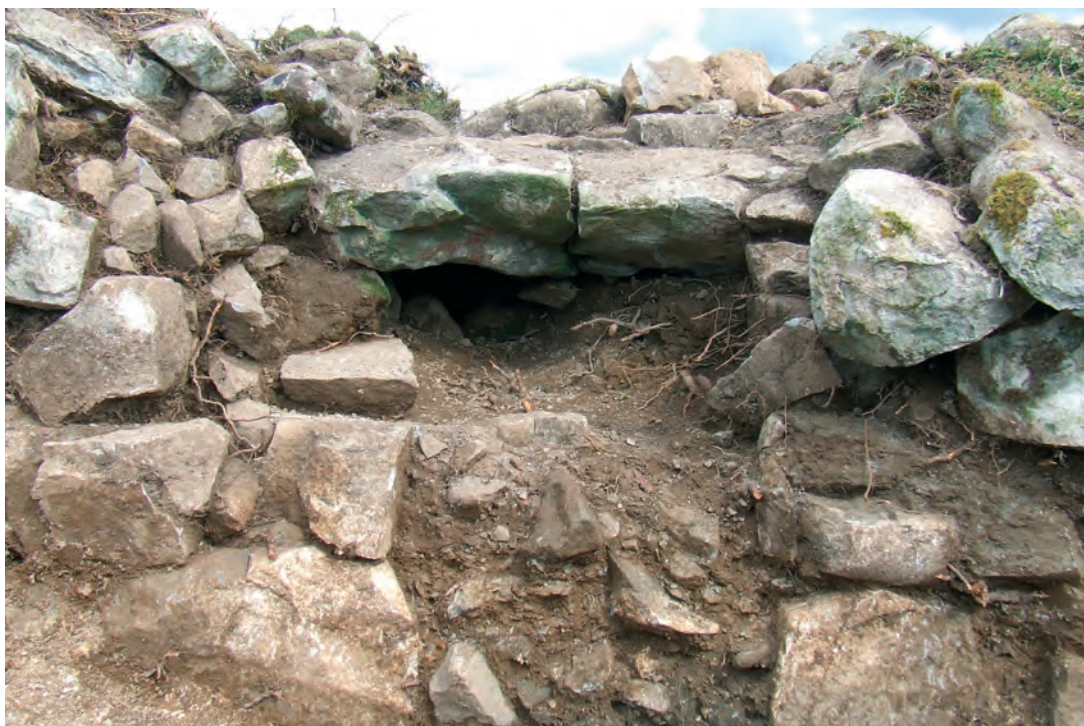
Plate 2: Blocked up flue in east wall.

The flues were all keyhole-shaped in plan, with a linear straight-edged cut and a rounded bowl-shaped end. The south, east and west flues within the wall were covered with stone slab lintels and the walls of the flues were partly stone lined. Each flue had been blocked up small rubble; and infilled with stone, lime (C.10) and redeposited natural soils (C.6), presumably when the function of the structure altered. Each external flue entrance showed signs of intense *in situ* burning, indicating that the reducing fire may have been lit and maintained at the flue opes.

The east wall (C.5b) was 3.63 m in length, 0.56 m in width and 1.60 m at its highest point. The opening (0.50 m) in this wall was again defined by squared blocks and a large slab lintel (Plate 2). The flue (C.7b) was 'keyhole' shaped in plan and splayed from 0.50

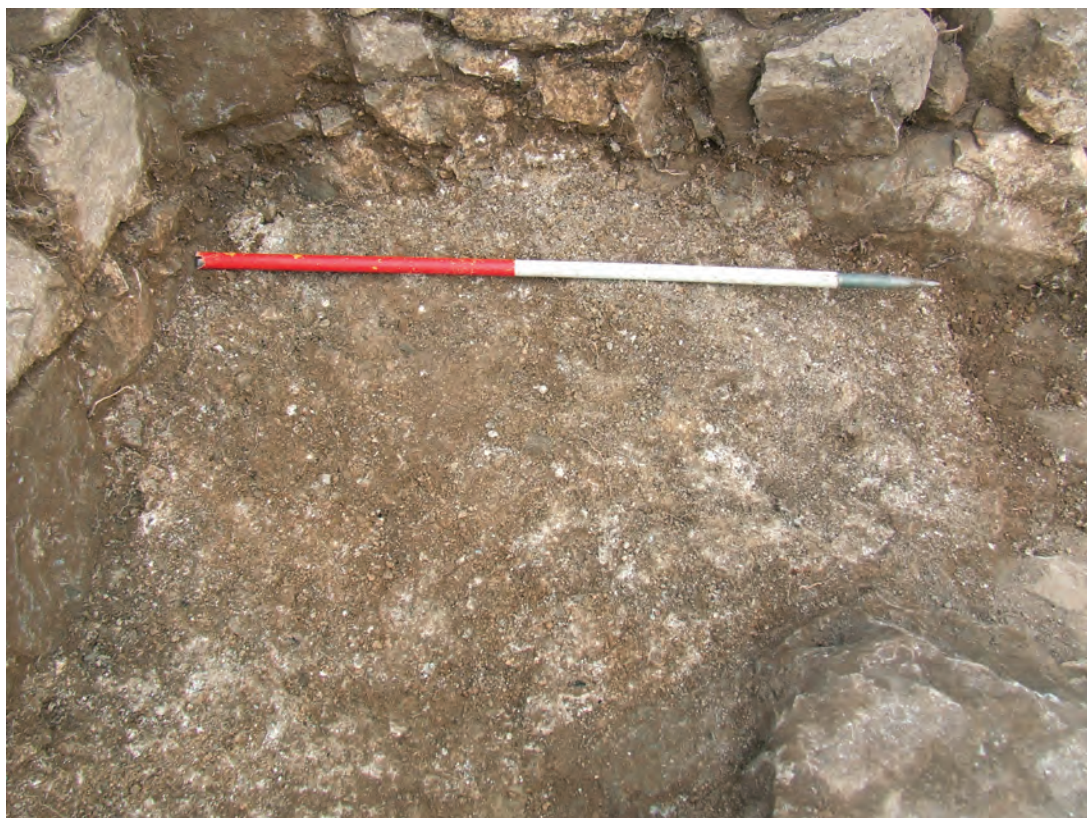
Plate 3: Burnt lime deposit in south-east corner.

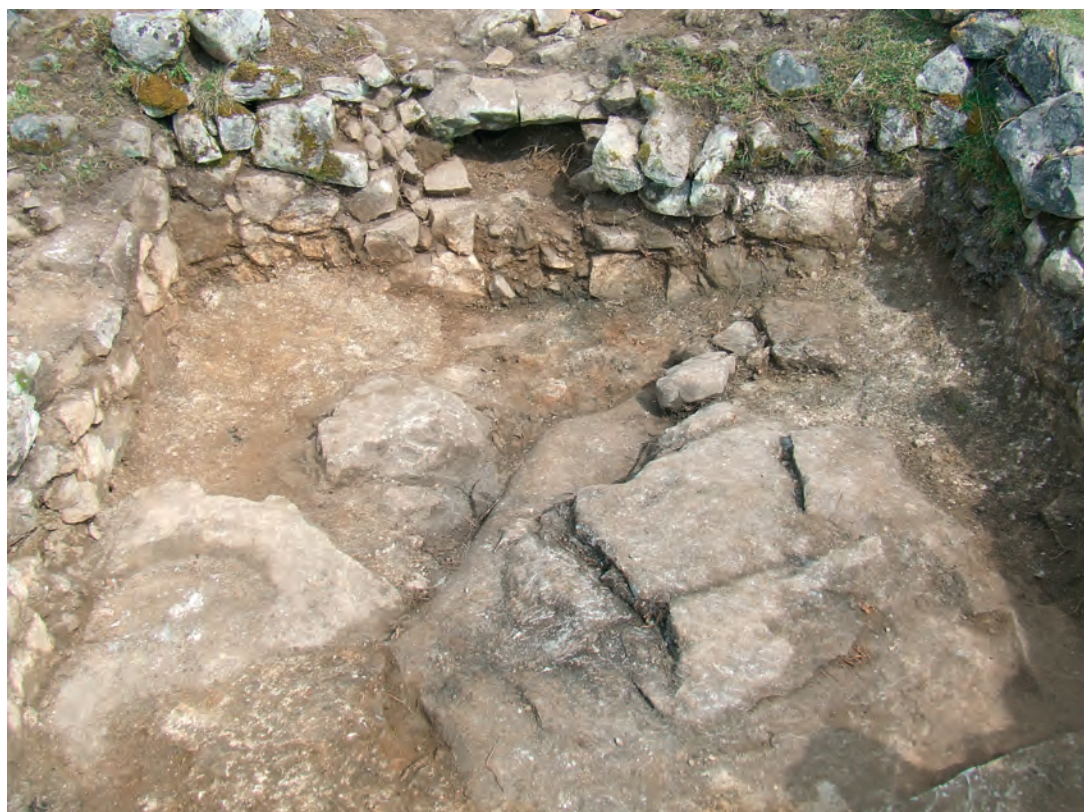
Plate 4: Floor and east wall.
