**N2 CLONTIBRET TO CASTLEBLAYNEY ROAD
REALIGNMENT**

**FINAL REPORT ON
ARCHAEOLOGICAL EXCAVATION
AT
SITE 101, KILCROW 1
TOWNLAND: KILCROW
CO. MONAGHAN**

IRISH ARCHAEOLOGICAL CONSULTANCY LTD

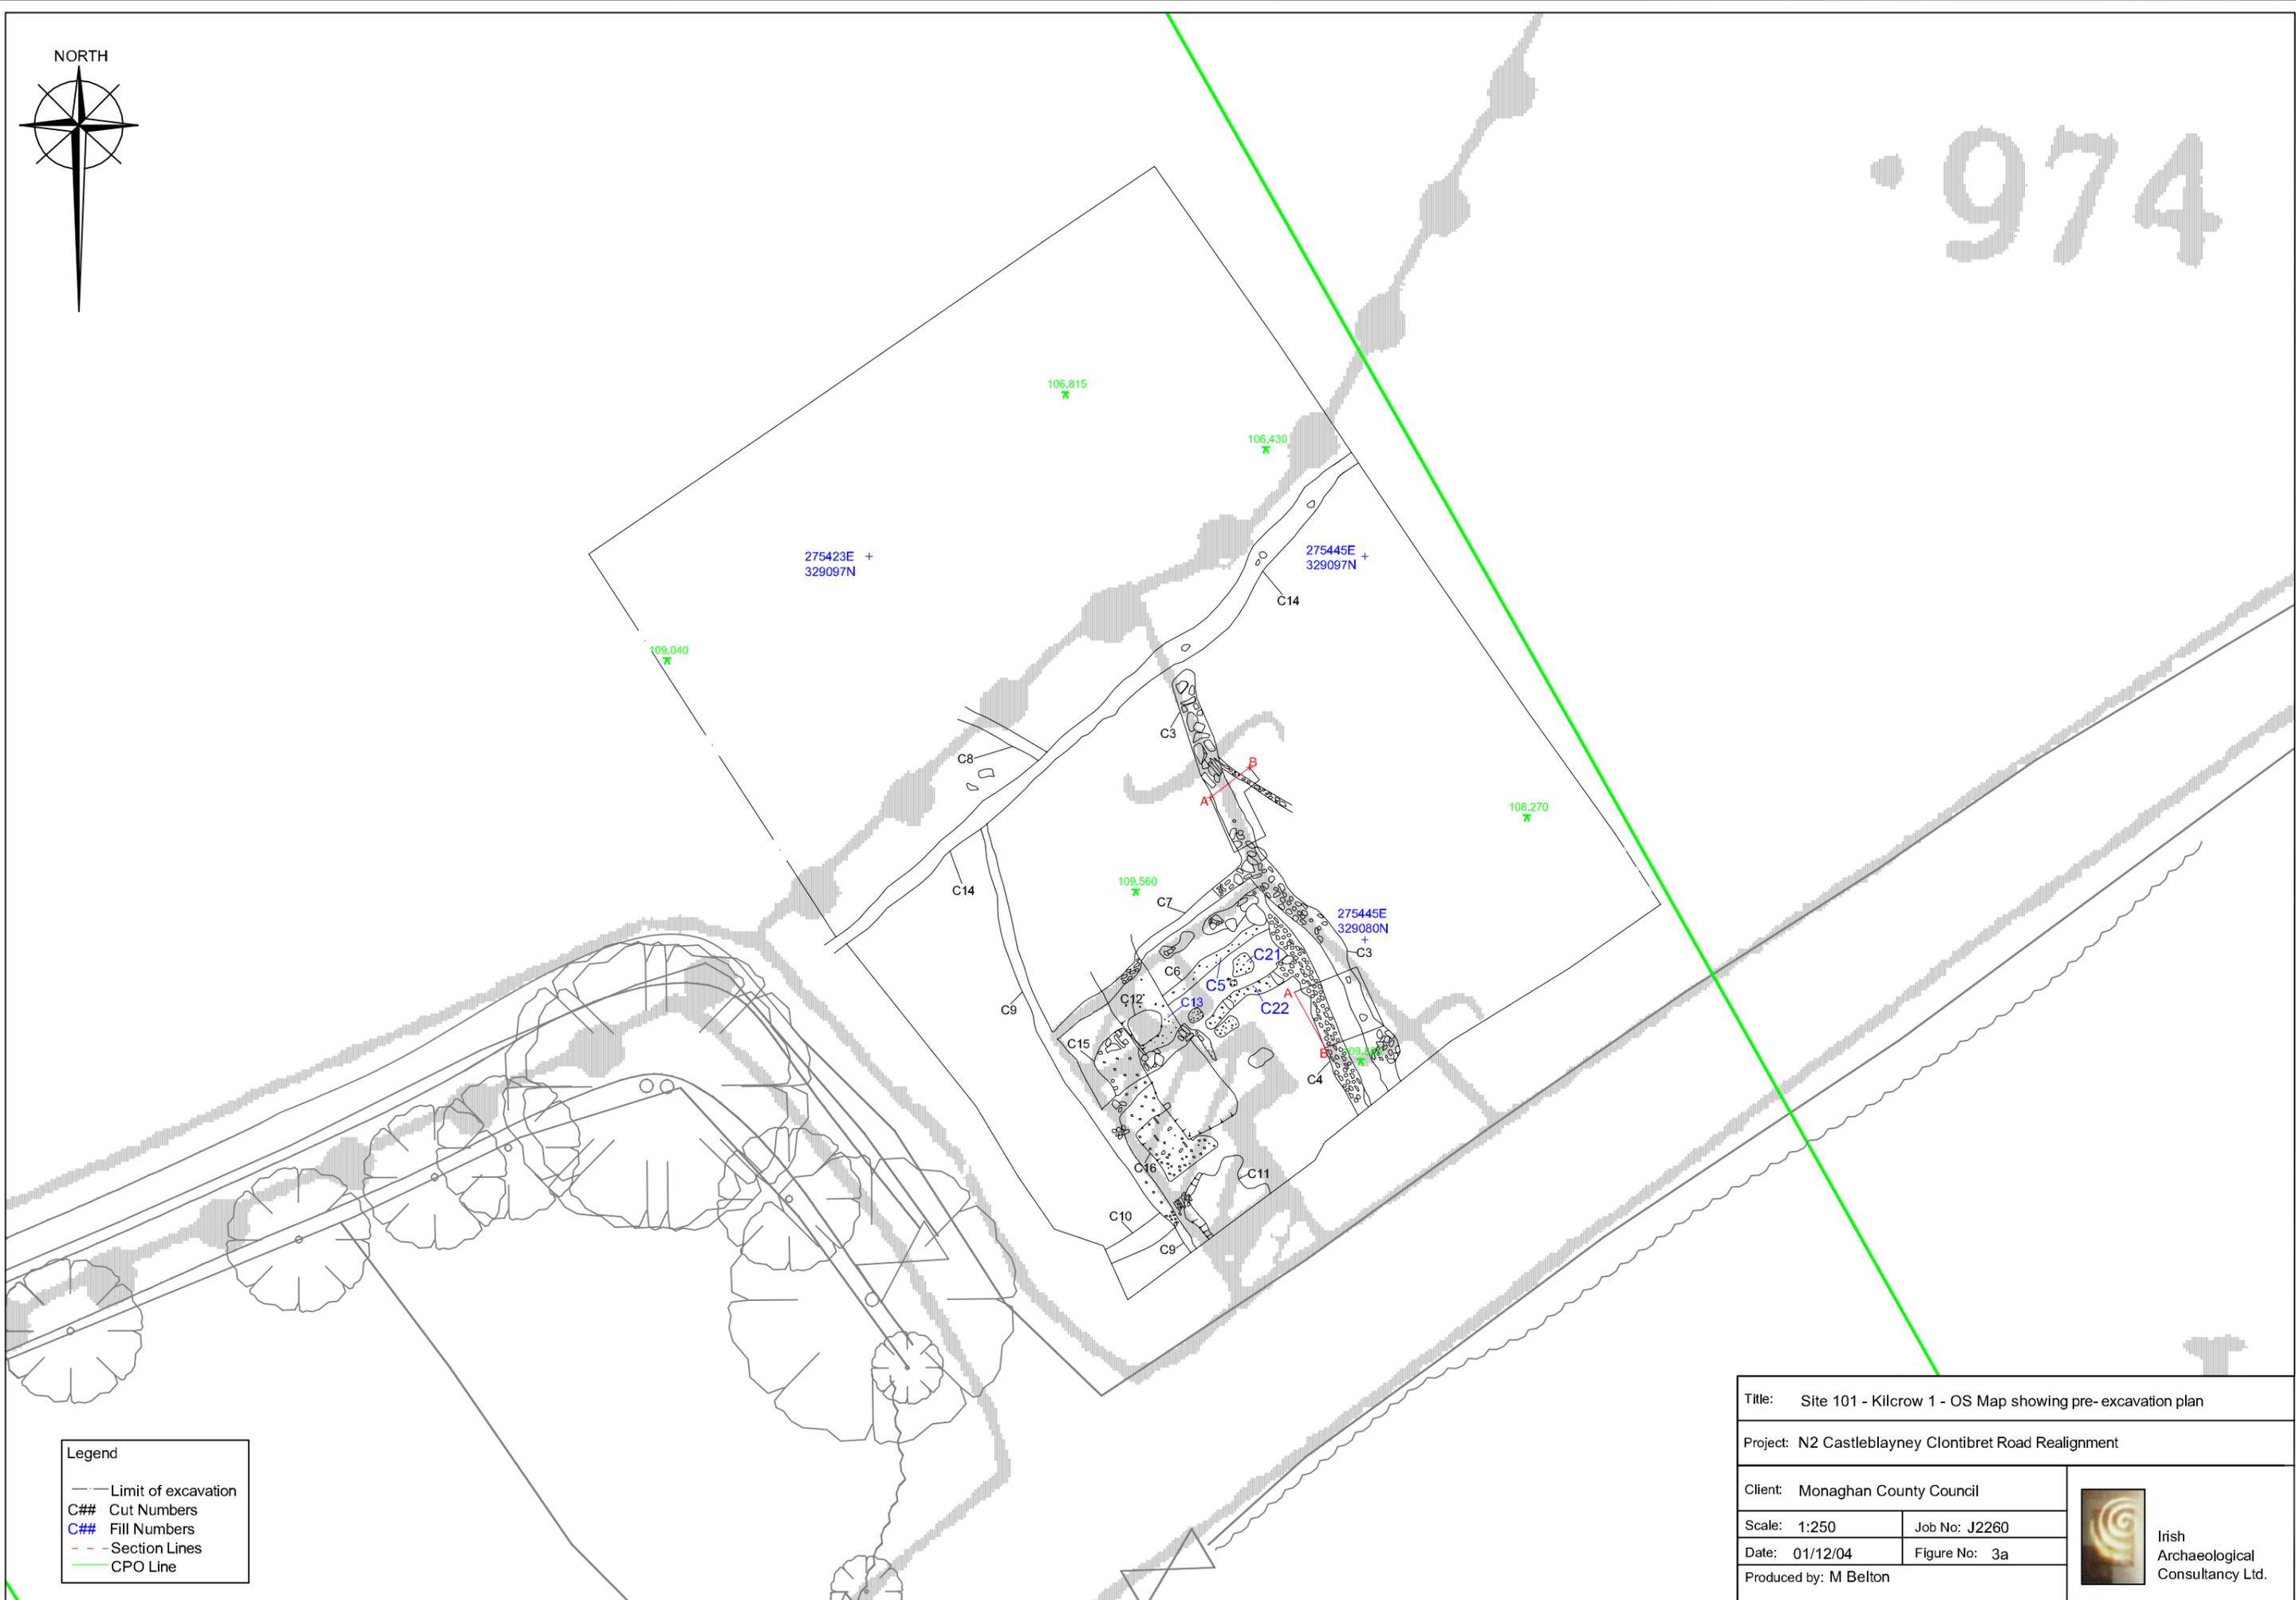
Title: Site 101 - Kilcrow 1 - OS Map showing pre-excavation plan	
Project: N2 Castleblayney Clontibret Road Realignment	
Client: Monaghan County Council	
Scale: 1:250	Job No: J2260
Date: 01/12/04	Figure No: 3a
Produced by: M Belton

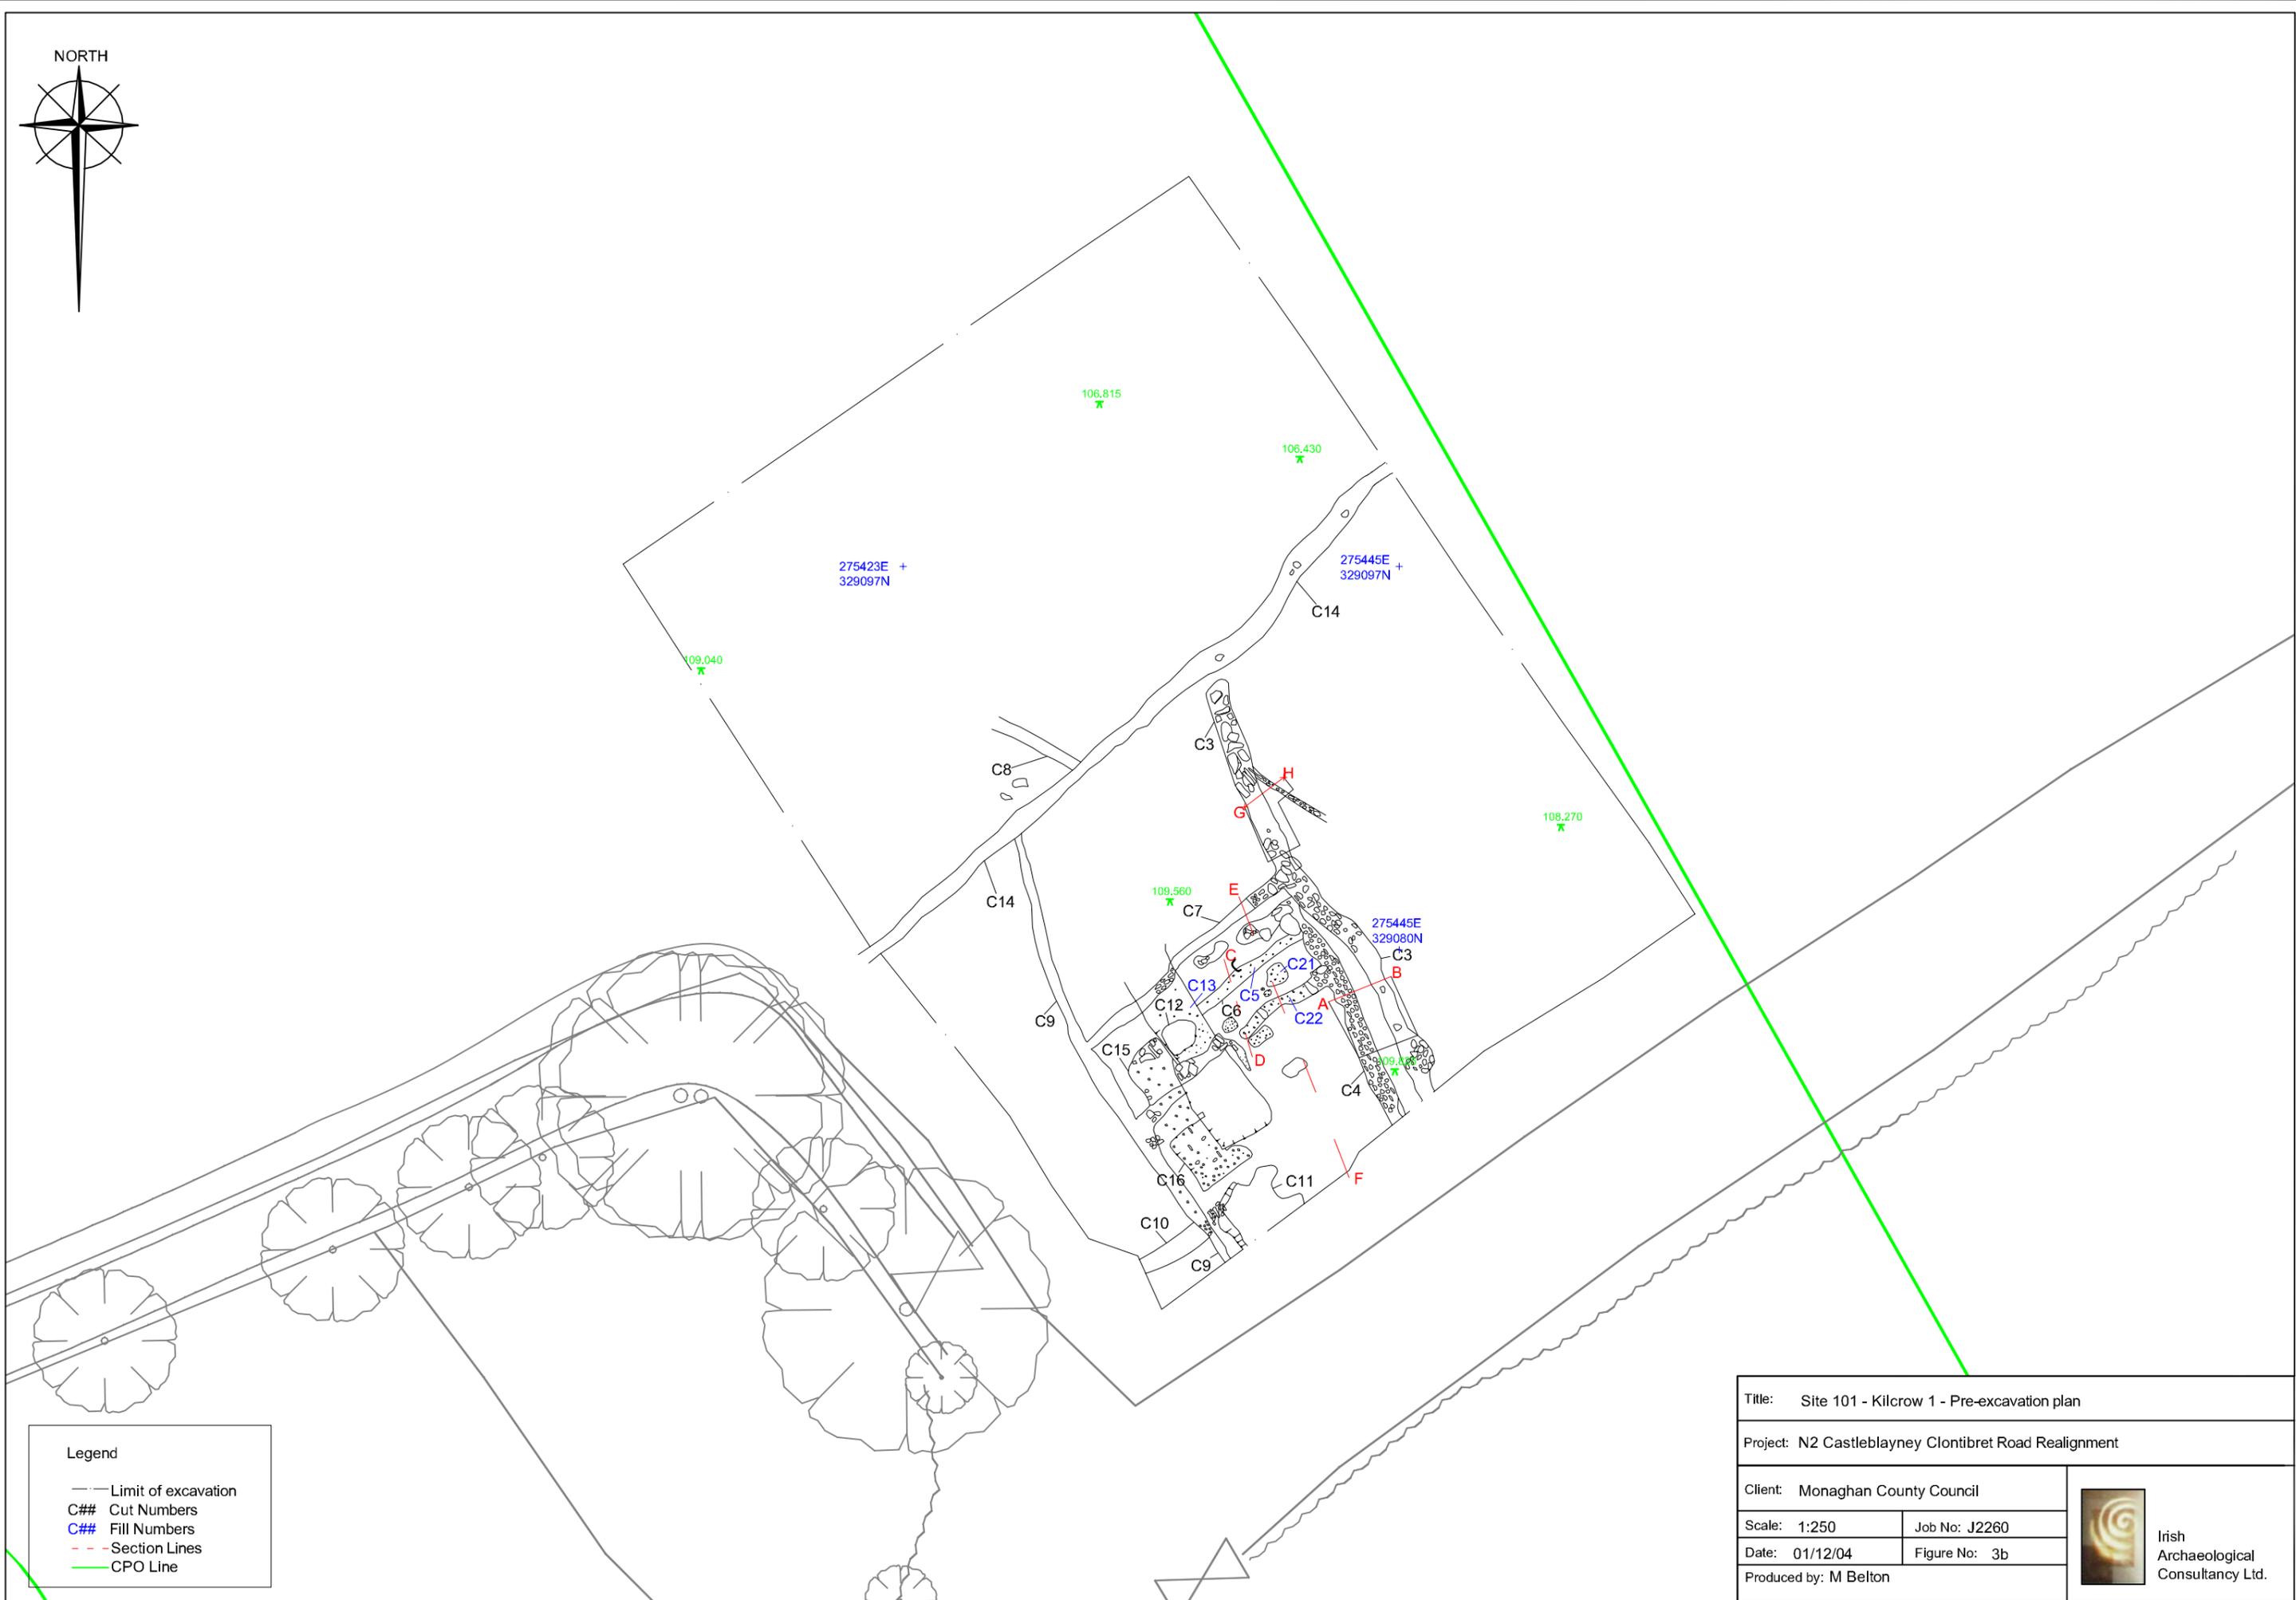
Title: Site 101 - Kilcrow 1 - Pre-excavation plan	
Project: N2 Castleblayney Clontibret Road Realignment	
Client: Monaghan County Council	
Scale: 1:250	Job No: J2260
Date: 01/12/04	Figure No: 3b
Produced by: M Belton

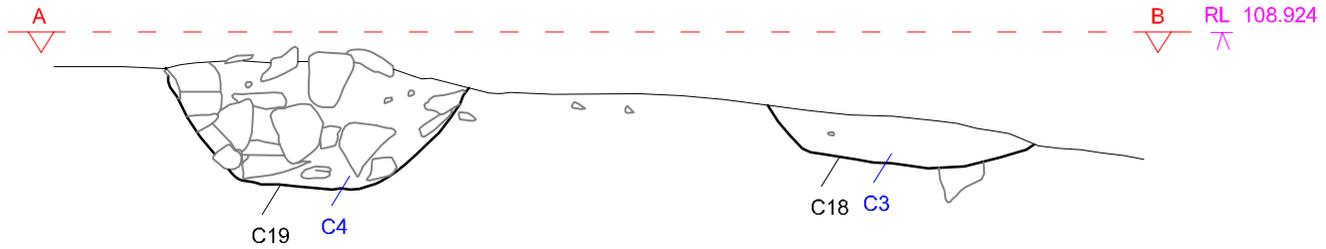
Site 101 - Kilcrow 1
Mid- ex of South facing section of C3, C18, C4 and C19

Title:	Site 101 - Kilcrow 1 - South facing section of cut of possible external wall of house [C19]
Project:	N2 Castleblayney - Clontibret Realignment
Client:	Monaghan County Council

Two parallel linear features were identified on the eastern extent of the site [C3] and [C4] (Plates 2 & 9). The larger of the two [C4] was a shallow U-shaped feature running 10m NE/SW having a depth of 0.35m with sharp clear edges and a flat base. On excavation this feature was identified as the possible remains of an enclosing wall which was identified on the 1907/1909 OS map (Figure 4). It is filled by (C19), mid-brown loose sandy silt with very frequent small and medium sub-rounded and sub-angular stones with frequent inclusions of gravel and pebbles. There was post-medieval pottery and delft-ware found within its fill, (Find 7).

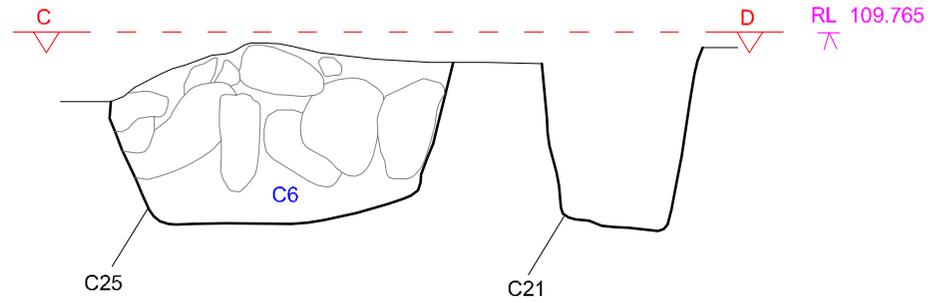
Site 101 - Kilcrow 1
South facing section of C25 & C21

Scale:	1:10
Date:	21/12/05
Produced by:	R Fitzgerald
Job No:	J2260
Figure No:	5

The cut of the foundation wall of the house [C25] runs E-W with sharp sides and a flat base. It measures 0.45m N-S with a depth of 0.22m (Figure 5). It is filled by a mid brown silty clay (C6) with a frequent medium sized well sorted angular stones. The fill is very stony and similar to that of a drain (Plate 3)

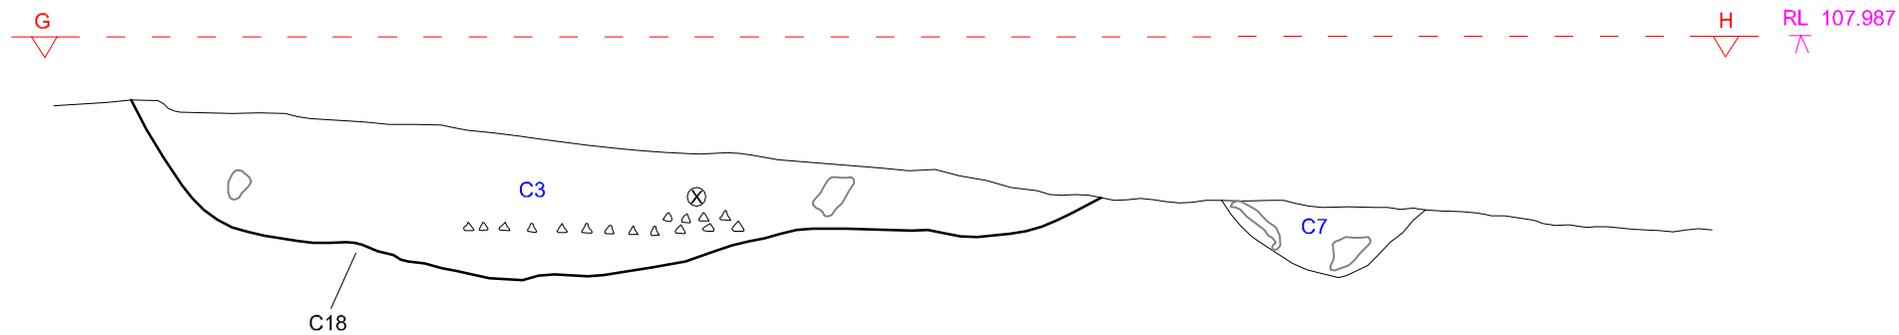
Site 101 - Kilcrow 1
 South facing section of C3 and C18

Irish Archaeological Consultancy Ltd.	Title:	Site 101 - Kilcrow 1 - South-facing section of cut of possible drain or external wall [C18] and "gully"	Scale:	1:10
	Project:	N2 Castleblayney - Clontibret Realignment	Date:	21/12/05
	Client:	Monaghan County Council	Produced by:	R Fitzgerald
			Job No:	J2260
			Figure No:	7

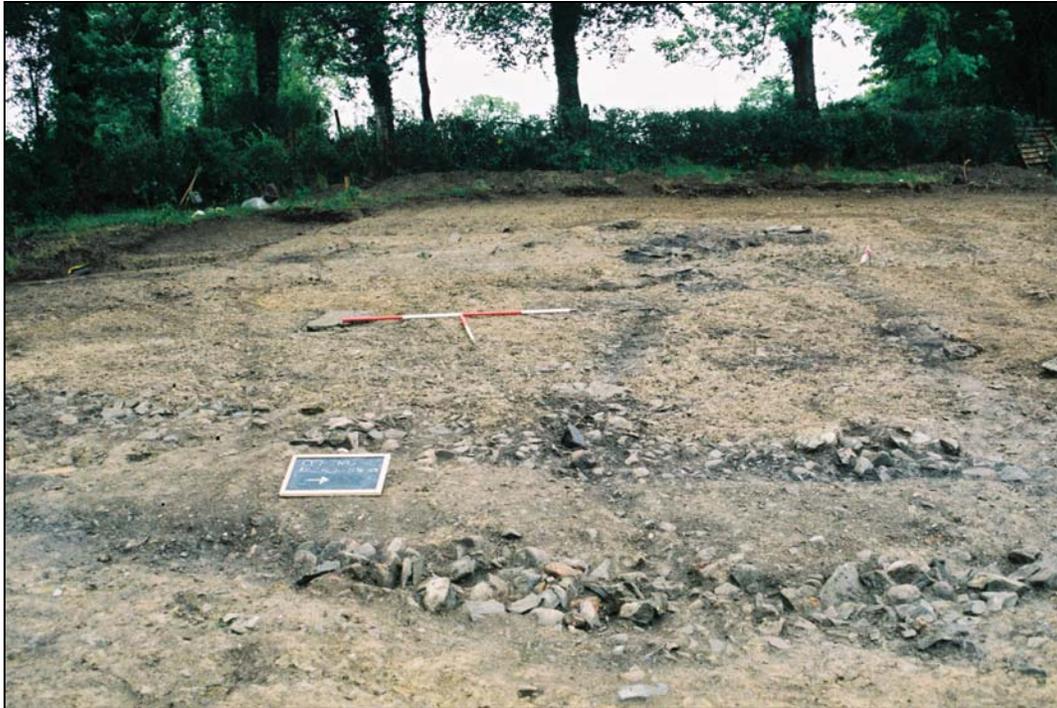
Plate 1 – View of house, looking W

DESCRIPTION: The foundations of a post-medieval/modern house were identified and excavated (Plate 1).

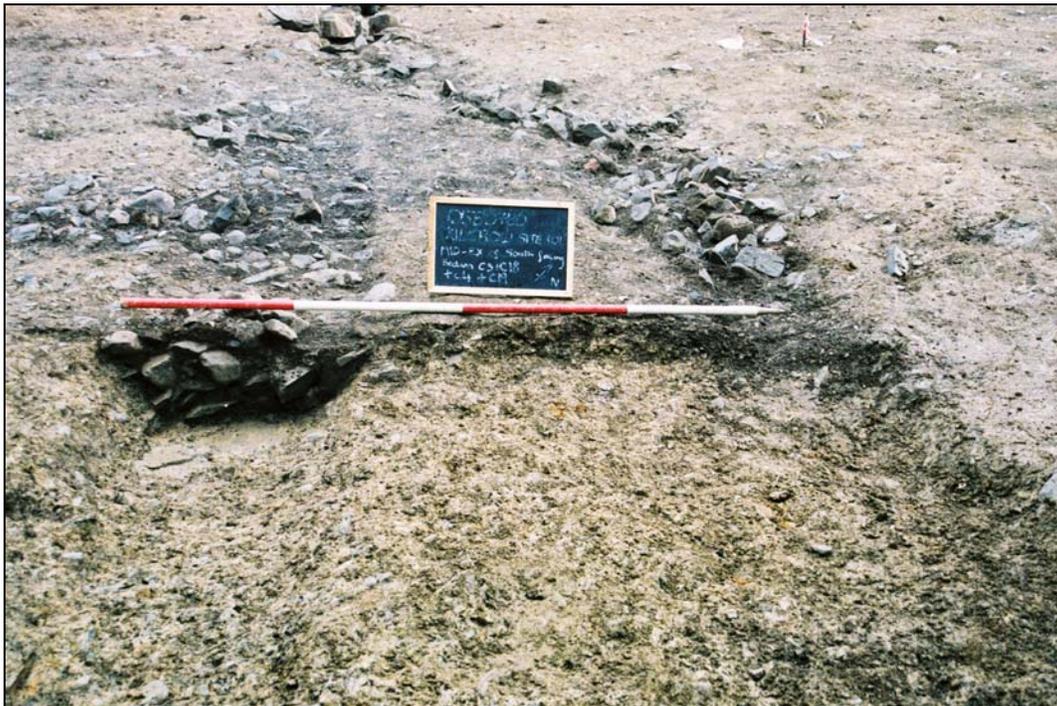
Plate 2 - SE-facing section of possible foundation wall (C3) and [C4] taken from NW

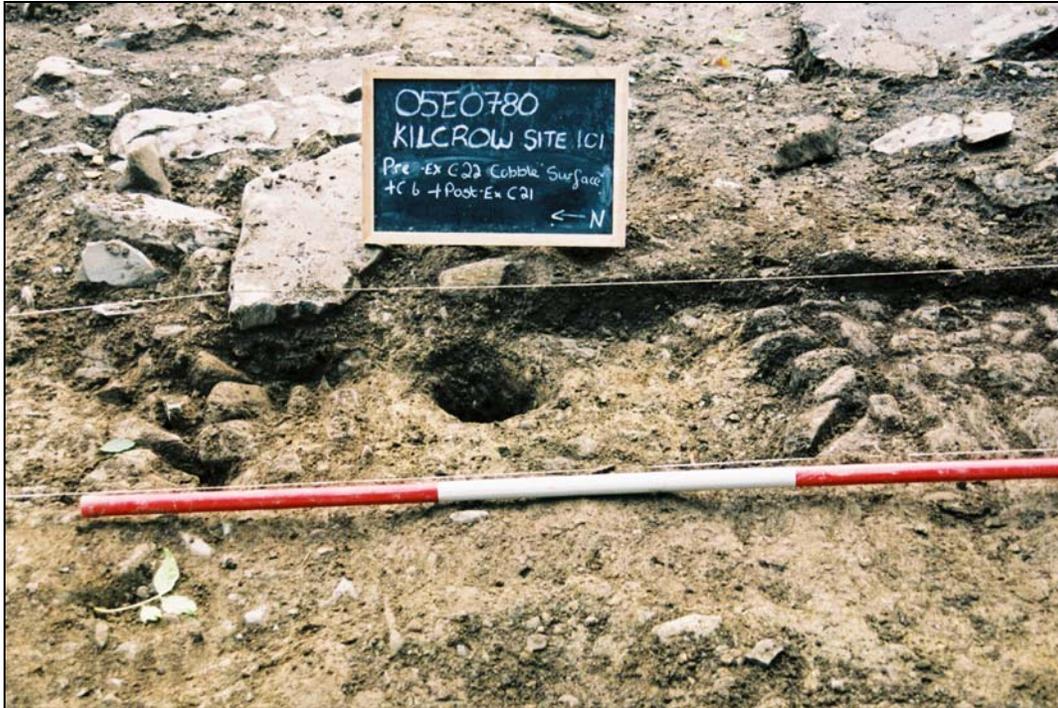
Plate 3 - Pre-excavation view of external wall [C6] showing fill (C22), post-excavation view of [C21] taken from W

The cobbles were left *in situ* and it's likely they extend under or form part of floor surface (C15) to the east and the west. Just north of this cobbled area was a post-hole [C21] filled by (C22) (Plate 3). It is sub-circular shaped in cut and its dimensions are 20cm N-S, 20cm E-W with a depth of 24cm. It has a sterile, loose fill with no inclusions and is comprised of mid brown silty clay.

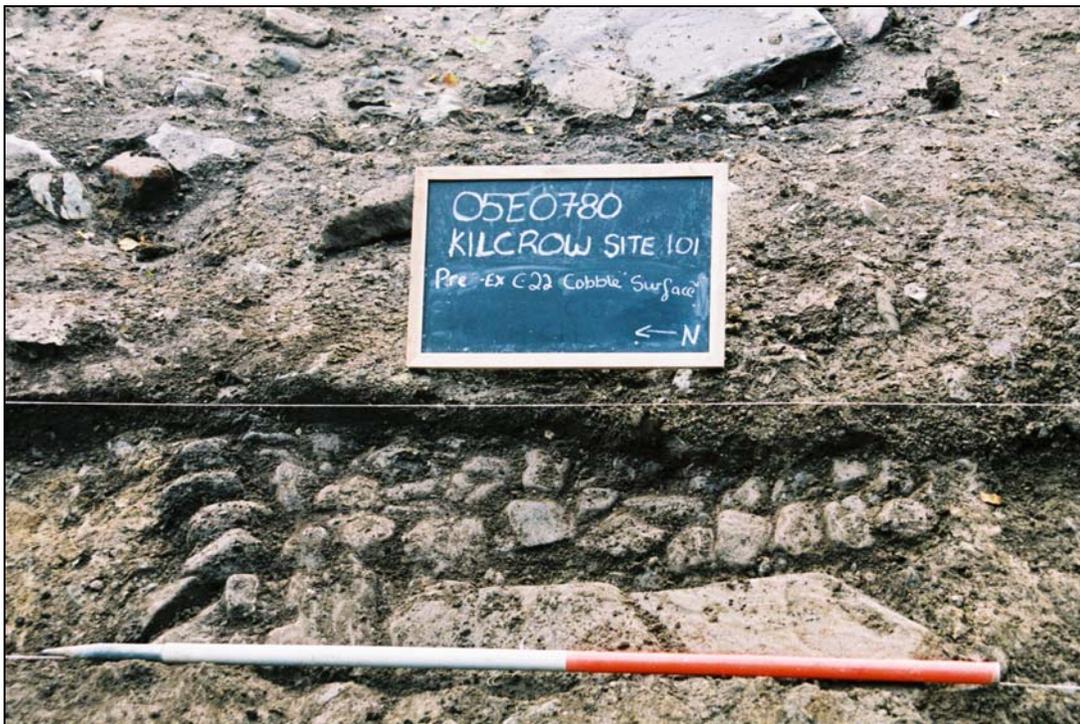
Plate 4 - Pre-excavation view of cobbled surface to the S of [C21], in N-S facing trench

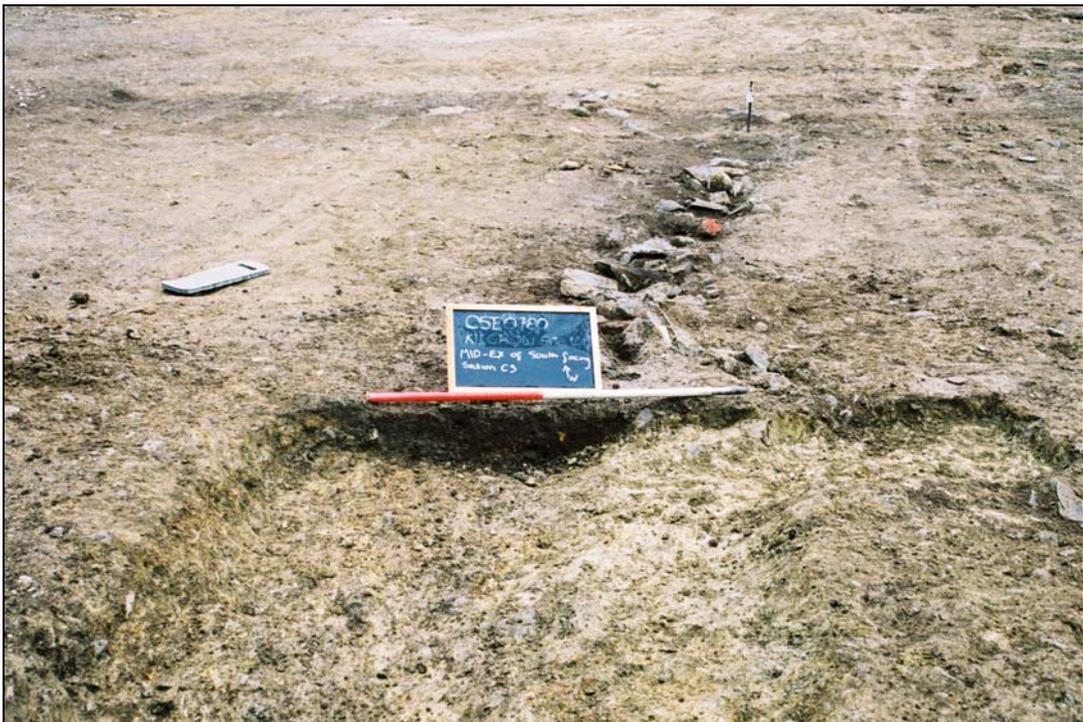
Plate 6 Mid-excitation view of S-facing section of possible foundation wall or drain (C3) also showing SW-NE running gully

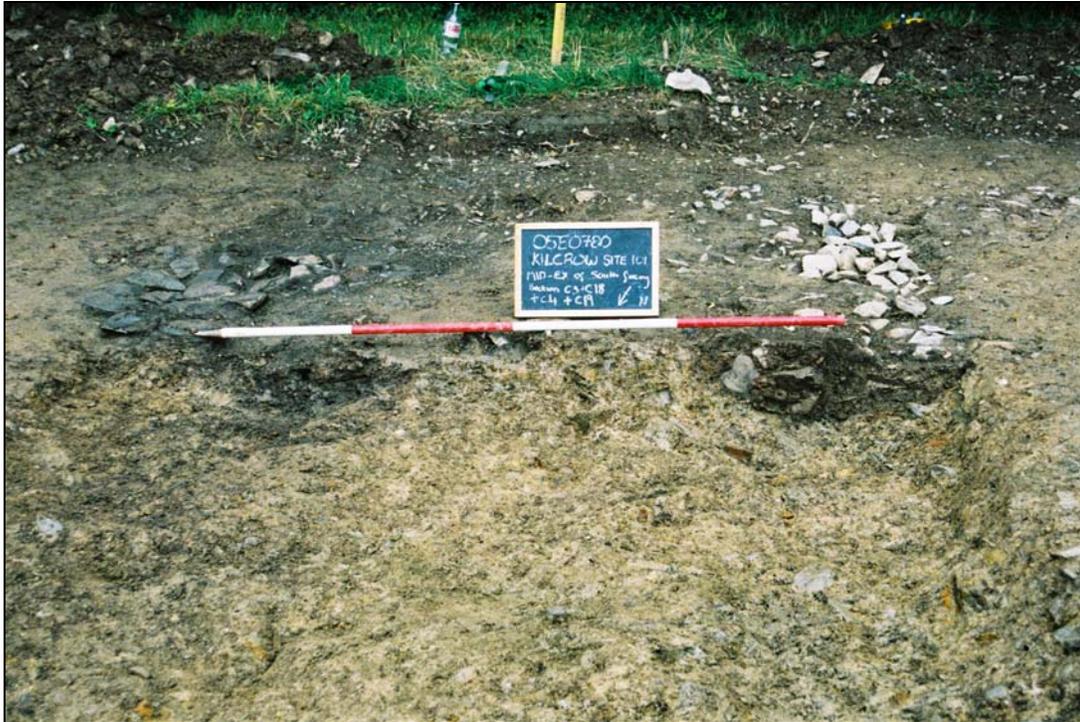
Plate 7 - NW facing section through possible foundation wall or drain (C3) and [C4], taken from the SE

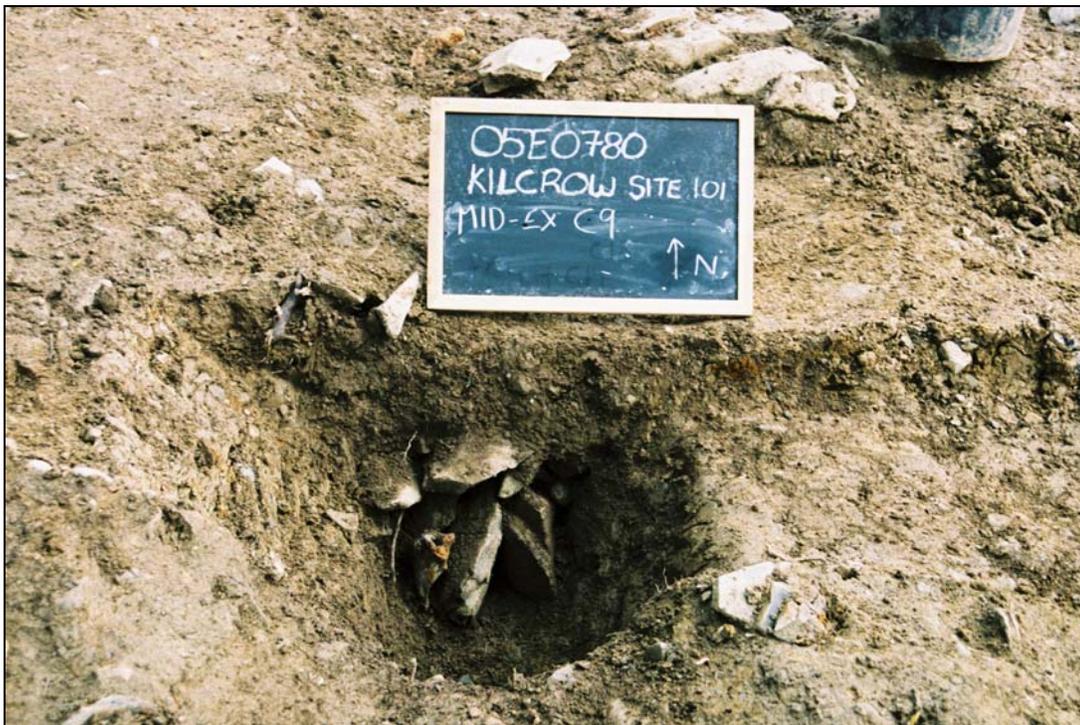
Plate 8 - Mid-excavation view of S-facing section of possible drain (C9), in E-W excavation trench

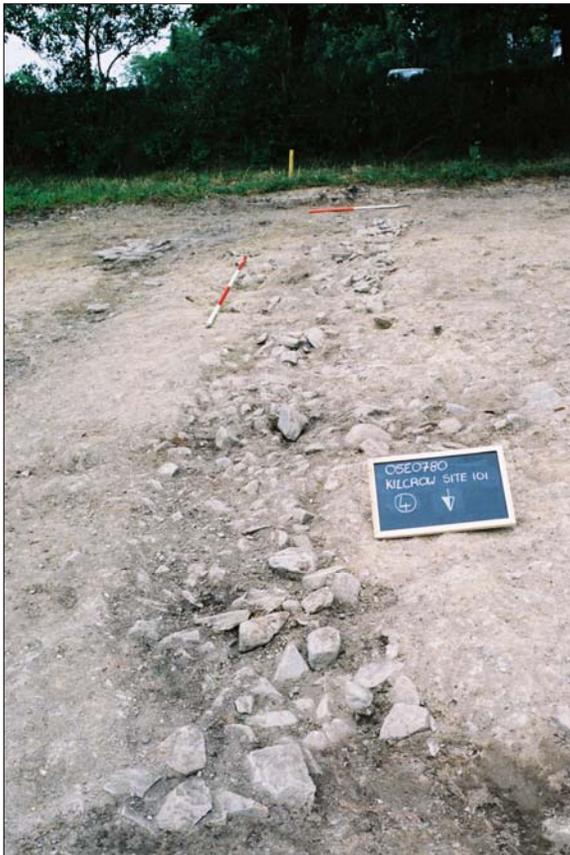
Plate 9 - View of foundation wall/drain [C4] taken from N

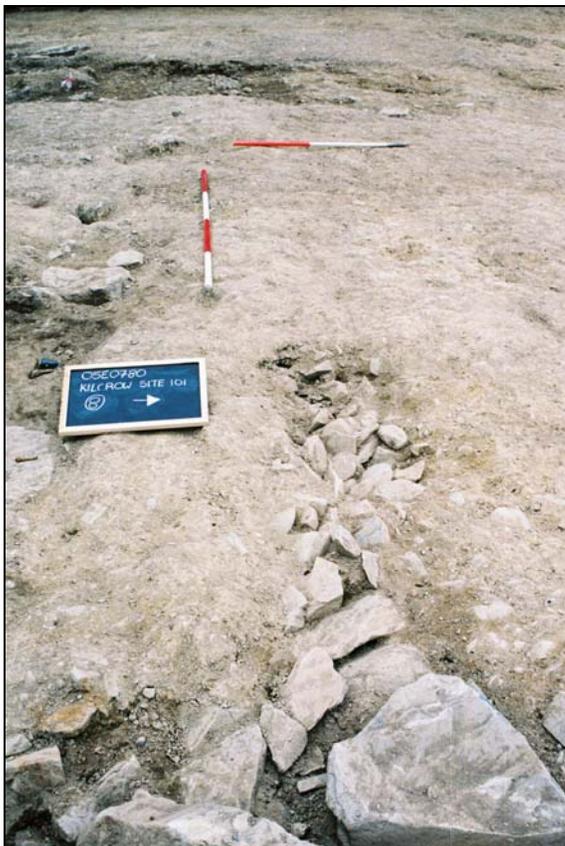
Plate 10 - View of foundation wall/drain [C26] (C8) taken from E

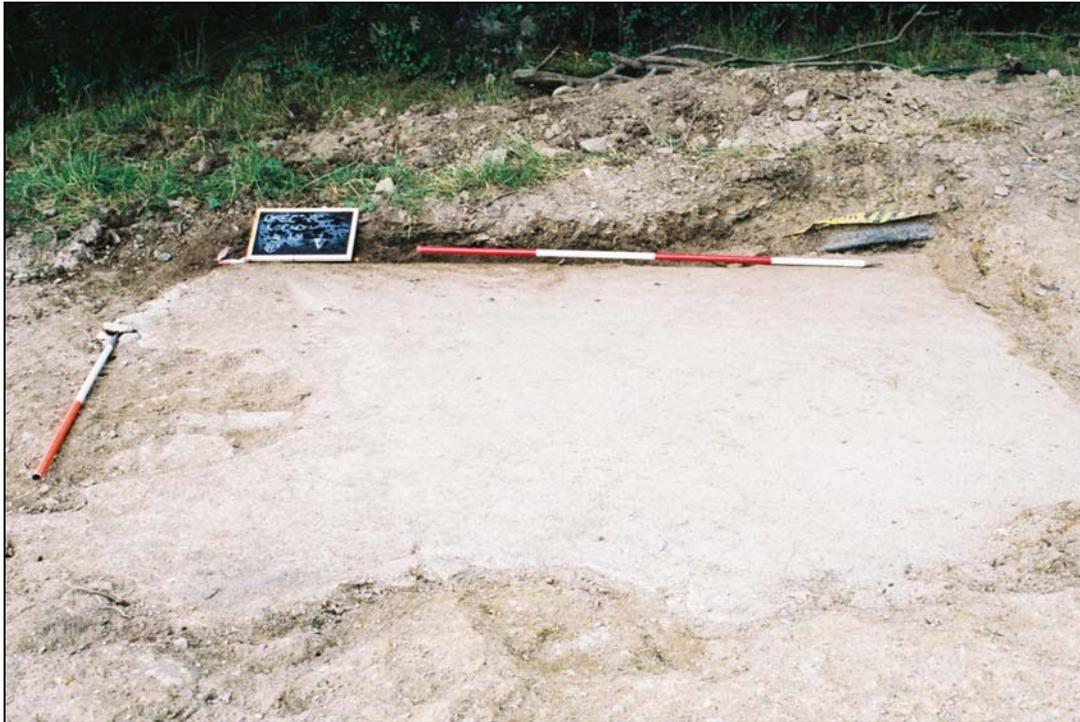
Plate 11 - Modern concrete floor (C11), taken from N

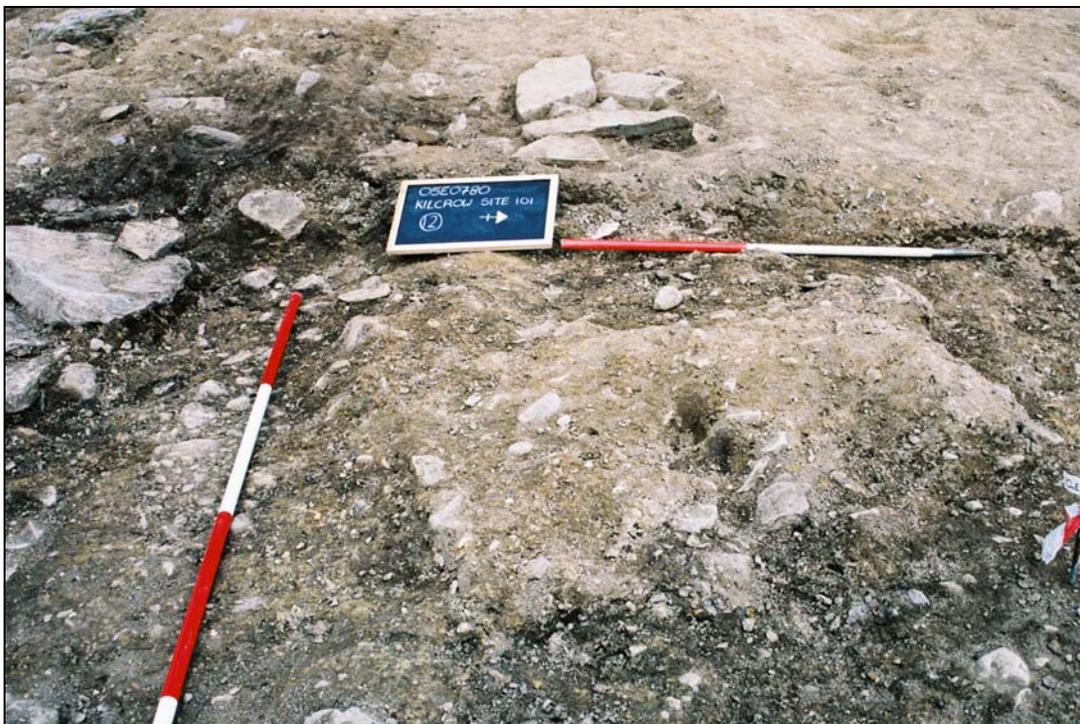
Plate 12 - Re-deposited natural in front of possible doorway (C12) looking E

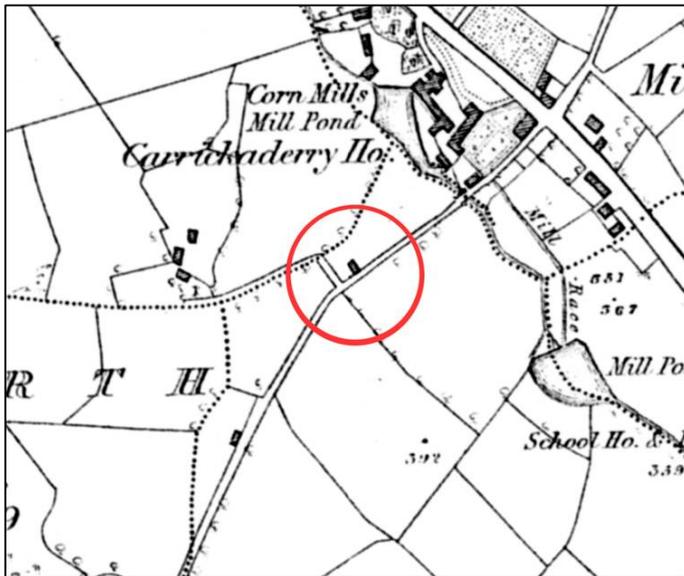
Fig 3.2 1858 OS six-inch map (rescaled to 1:5000).

A building is shown at this location on the 1858 OS six-inch map, but not on the 1835 map (Co Monaghan sheet 14; fig 3.2). This indicates that it was not until the mid 1800s that this site was built upon.

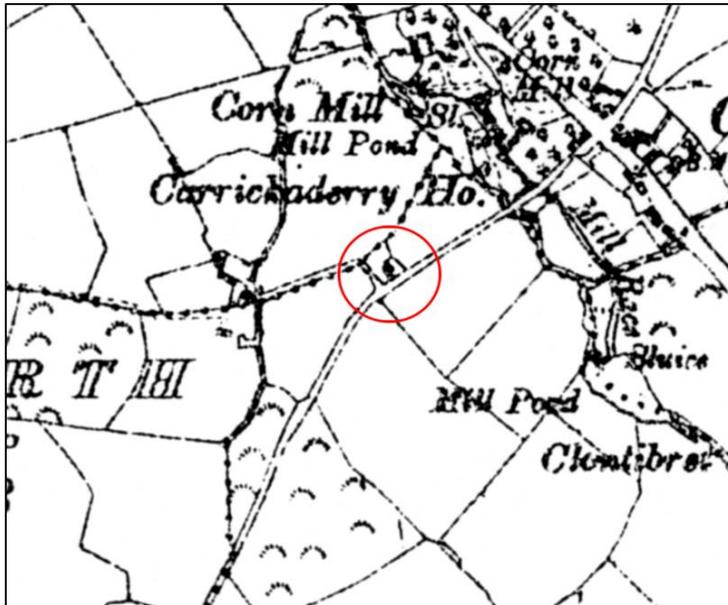
Fig 3.3 1908 OS six-inch map (rescaled to 1:5000).

Abraham Reid took possession before 1880 and he was succeeded by William Alexander Reid c.1907.² The buildings are shown on the 1908 OS six-inch map (fig 3.3). Their size and layout is similar to those on the 1864 map, indicating that no significant alterations or rebuilding had taken place in the intervening period.
