N25 YOUGHAL BY-PASS

EXCAVATION OF ISOLATED FEATURES AND RECORDING OF STANDING BUILDINGS, YOUGHAL BY-PASS, CO. CORK.

Licence: 01E0543

**ARCHAEOLOGICAL CONSULTANCY
SERVICES LIMITED**

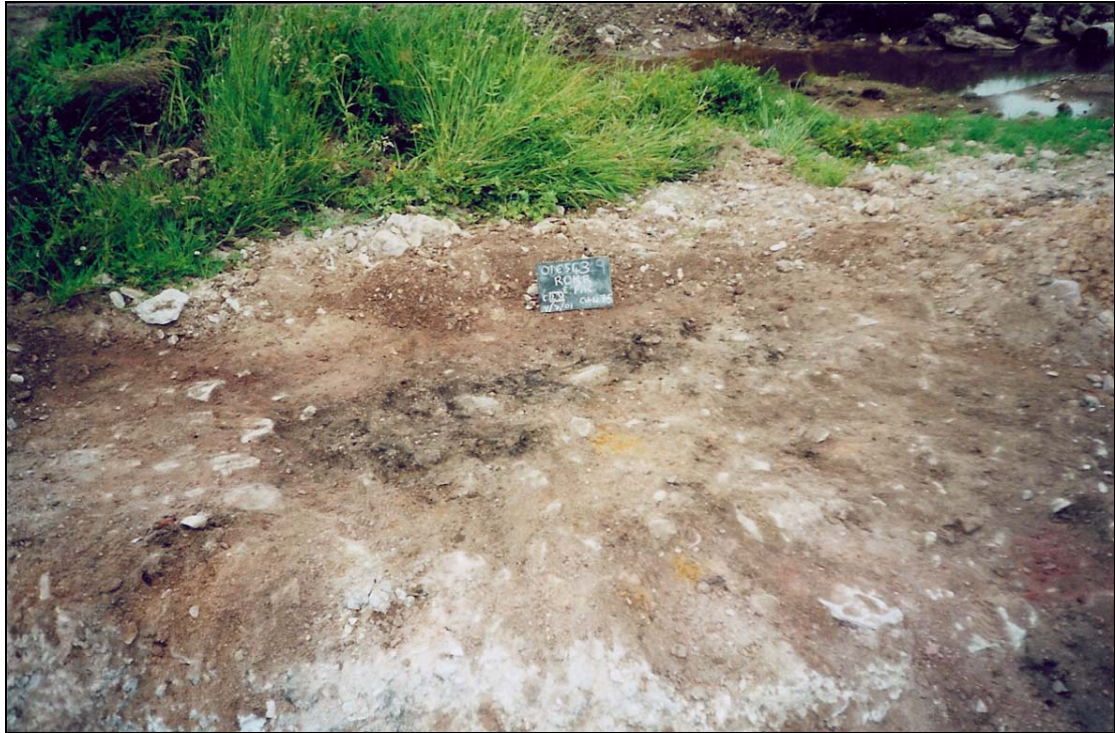
The area most affected by the damage was visible at C23 (a), a 0.35m deep by 1.1m wide pit which was partially truncated by the machine. The remainder, however, was visible in section. The area itself consisted of a burnt spread which was revealed during topsoil stripping/testing. Initially, the spread covered an area of 2 x 2.3m but further investigation revealed that the full extent of the spread measured 1.4m. A small test trench was then cut through this and continued for 1.3m north of the contractor's trench.

Plate 4, **AR28**, spread of burning, looking southwest

Investigation of the remaining archaeological deposits at AR28 suggests that this was not a *fulacht fiadh* as originally suspected but rather an area containing a small circular concentration of burning with an associated silty charcoal spread surrounding it. The extent of damage to the archaeological deposits by the contractors' trench was limited to the partial truncation of C23 (a), (b), and (c) as described above. No finds were retrieved from the site.

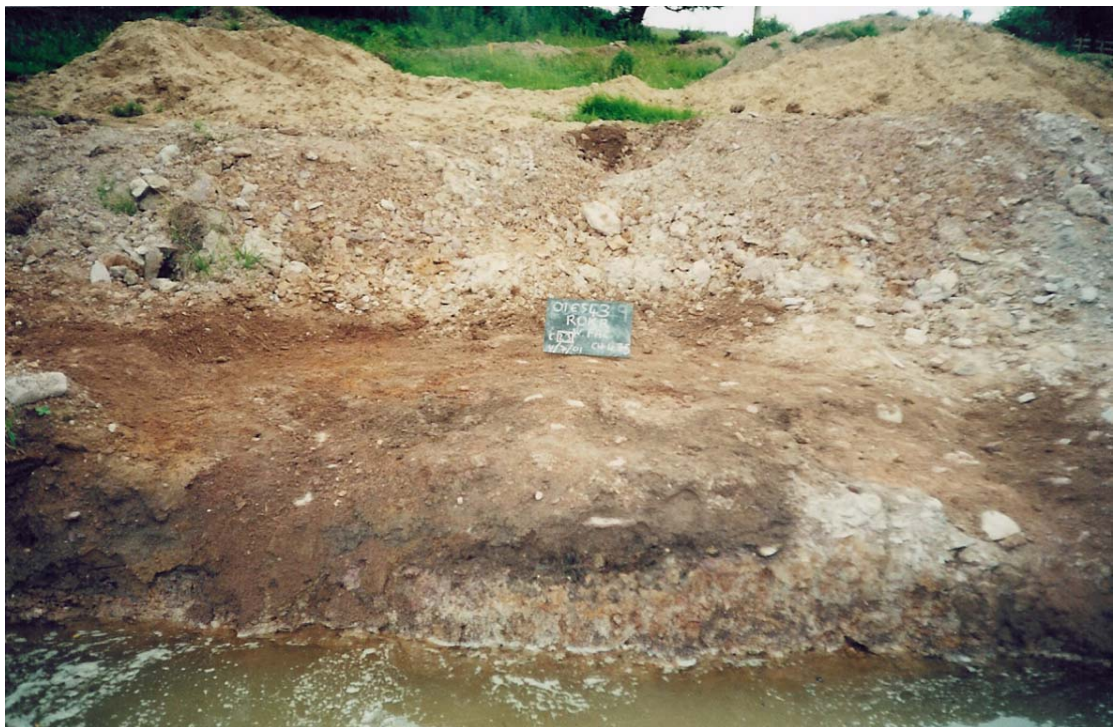
There were two discernible cuts into the subsoil. One of these, **C23 (a)**, being a pit measuring 1.10m in a north to south direction by 0.35m to 0.40m in depth. Its east to west dimensions, however, could not be ascertained as partial truncation by a machine had occurred prior to excavation. It contained loose grey-black clayey silt with frequent charcoal and burnt sandstone inclusions. This was located north of the contractor's trench and was visible in its south-facing section.

Plate 5, **AR28**, Truncated Pit, looking southwest

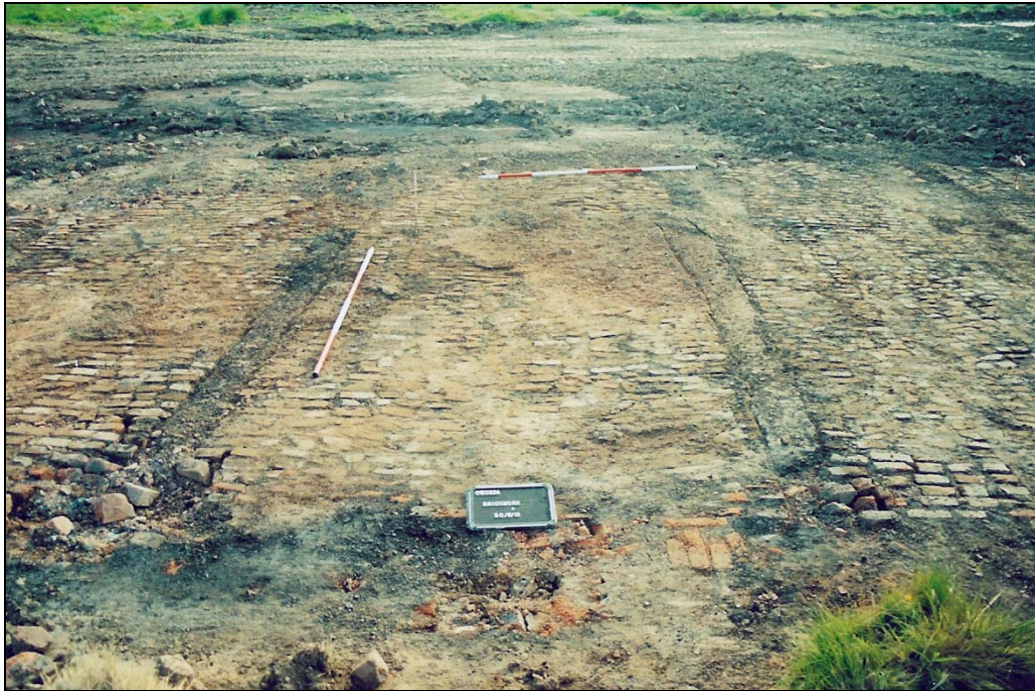
The bricks were laid down, stretcher on the flat, in rough columns with a small gap of approximately 2cm every three columns. A rough lean-mix style mortar and brick dust matrix bonded the bricks. After every ninth column of bricks, there was a dividing linear feature. The northern edge of paved area was marked by a row of bricks set lengthways at a right angle, header to stretcher. The bricks used for this paving were a mix of sizes and conditions though the average brick had dimensions of 200 x 100 x 600mm. The fabric was generally the same though colour varied with degrees of firing. All the bricks appear to be nineteenth-century in date. Some bricks

Plate 7, **AR1**, Brick Paved Area, looking southwest

The features uncovered at AR1 suggest that it relates to the latter stages of drying and firing. The brick paved area is possibly where the moulded bricks were placed to dry out before undergoing the firing process. The lack of any burnt material makes it is less conceivable that this area may have been the floor of a firing kiln. The fact also that the floor area was roughly rectangular in layout would also be more indicative of a drying station or plateau rather than a kiln floor. There are various methods involved in the drying-out process of historical brick (Pava and Bolton 2000, 191), all of which involve the circulation of air around the brick whilst under a protective covering. The 'hack' drying method was one where long rows of green bricks were stacked to a height of about 1m and allowed to dry out for a period of time before the final firing stage. This method could be carried out in the open air with the hack being covered temporarily with material such as straw or kept in sheds. The permanent nature of the construction of the brick paved area and the regular linear concrete features would suggest a shed structure for protecting the bricks during the drying process.

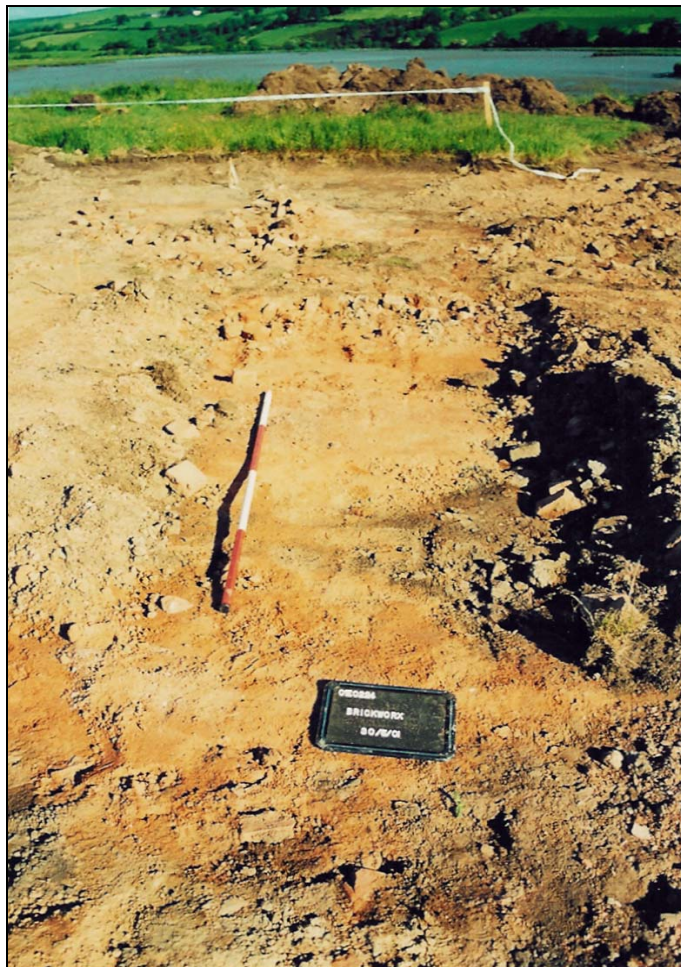
A low squared ridge (1m north to south, 23m east to west) of poorly bonded masonry ran between the paved area and the disturbed area and may have been the wide foundation course to an east–west running wall. A heavily-disturbed area (15m north–south by 23m east–west) lay to the south of the brick floor area. Occasional patches of laid brick were interspersed across an area of brick dust and occasional brick features of no discernable pattern. It was not possible to readily distinguish between oxidisation as a result of firing and the compact brick dust. Here, there was no evidence of a brick floor. There were deposits of loose brick and roof tile within the area but there was no discernible pattern to their distribution. This area may originally have been paved as the linear features appear to continue through it.

Plate 8, **AR1**, Disturbed Area, looking northwest

Whilst the area could be interpreted as an area of clamp kilns, the presence of the linear features running through the disturbed area and the inability to identify *in situ* burning from clamps, it is suggested that the disturbed area was part of the drying sheds. The brick-built drain could be interpreted as a purpose-built drain to facilitate the brick-making process. However, there is an alternative interpretation that could account for the presence of such a well-built feature. Often associated with brickworks are underground channels which carry the steam and smoke away from the main kiln areas and out under the drying plateaus (Anthony Breslin, *pers comm*). Without conclusive evidence, however, it is difficult to ascertain which interpretation, if either, is correct.

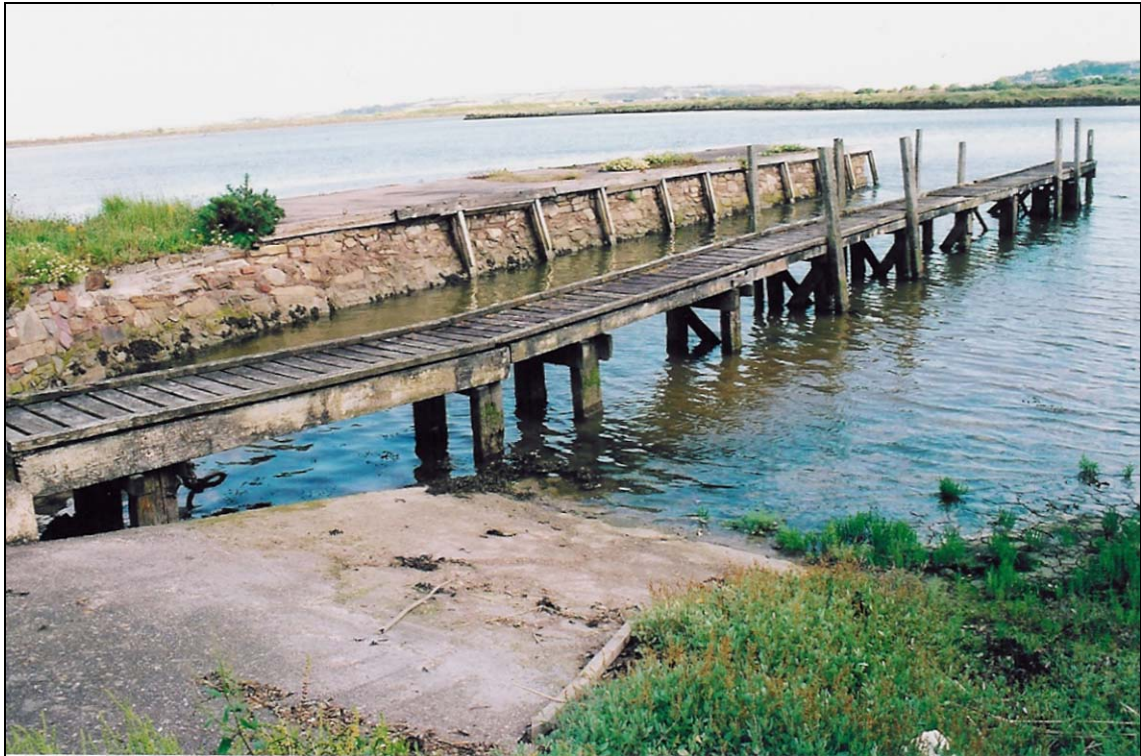
A wooden jetty orientated north–south is located to the south of the main house along the bank of the River Tourig. It was constructed by placing ten wooden beams into the riverbed and joining them by pairs of beams arranged in a crisscross fashion. A hundred or so wooden planks were then placed perpendicular to the upright beams to form the platform.

Plate 17, **AR32**, Stone Bridge Complex, Slipway, Jetty and Pier, looking southeast

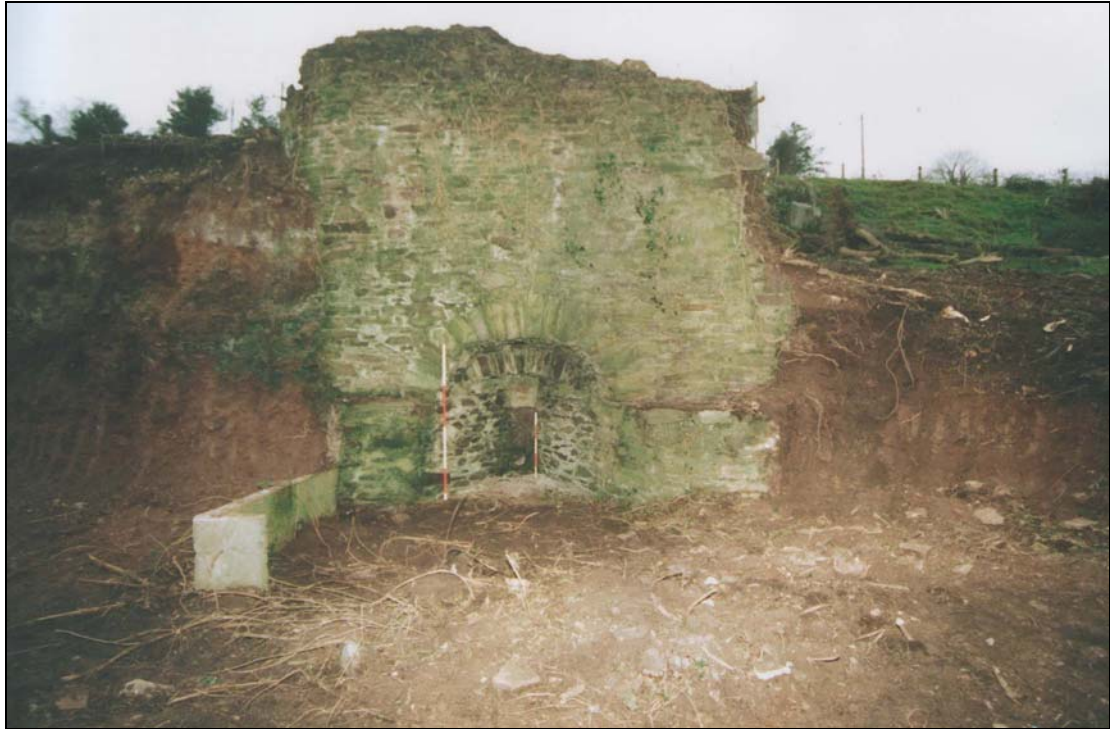
The elevation of the limekiln structure was roughly square, built of random mortar-bonded rubble sandstone with very rough quoins. The upper eastern part of the kiln has been heavily damaged and undermined by tree-root action. The upper portion of the elevation acts as a parapet retaining the chargehole area for the combustion chamber at the top. The elevation was 5.8m in height (including 1.08m of parapet wall) and 5.6m in width. A large drawhole was located in the bottom centre of the elevation and a projecting ledge of 1.3m in height was present on both sides of the drawhole. A well-built stone arch of twenty-five voussoirs formed the drawhole and was 2.7m in width and 2m in height at maximum. The intrados of the drawhole progressively reduced in size as it lowered towards the drawhole with a second arch of fifteen voussoirs spanning three large rectangular sandstone slabs that formed the base of the combustion chamber. The ingoings of the

Plate 19, **AR35** Limekiln elevation

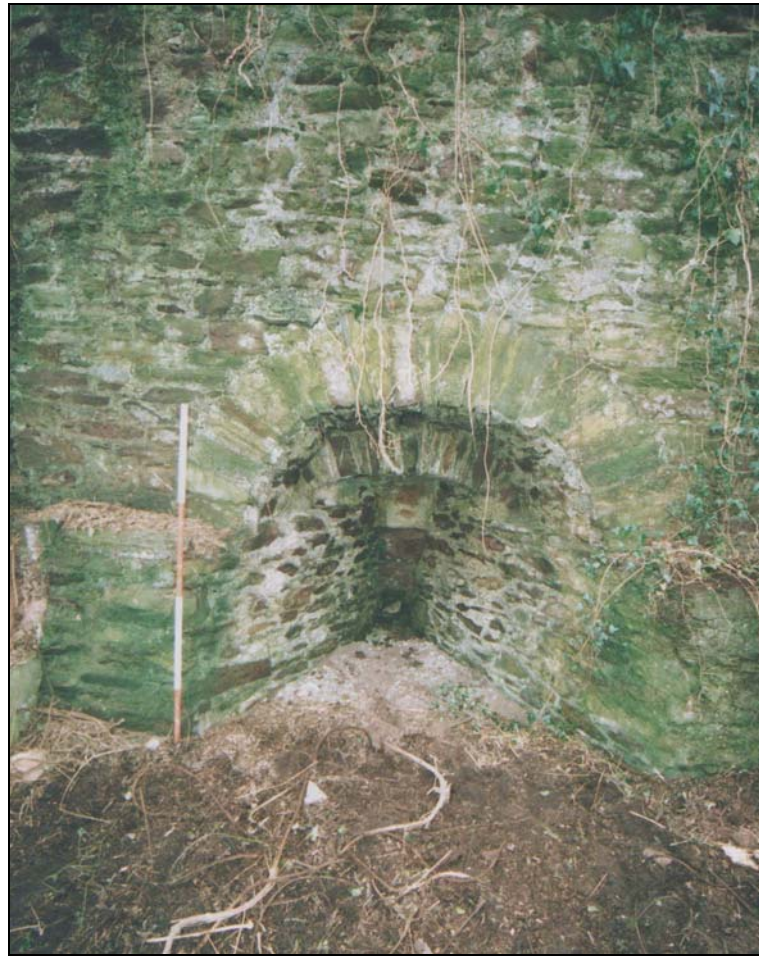
drawhole were deep. A small stakehole was located between the two arches of the drawhole. There was a distinct change in the masonry at a height of 2.6m with the lower fabric having tighter joints and more deliberate construction. Above this height, the joints are not as tight and appear to have been repointed. This may be a rebuilding of the upper parts of the kiln, though it is more likely to have been as a result of the expansion and contraction of the structure during the lime burning process.

Plate 22, **AR35** Detail of drawhole

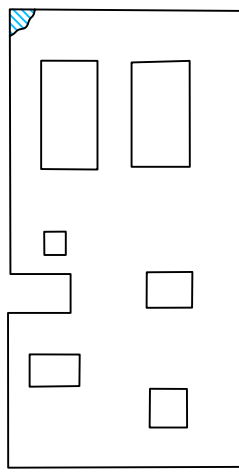
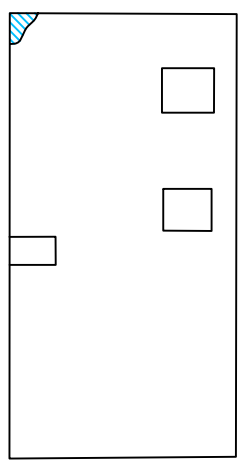
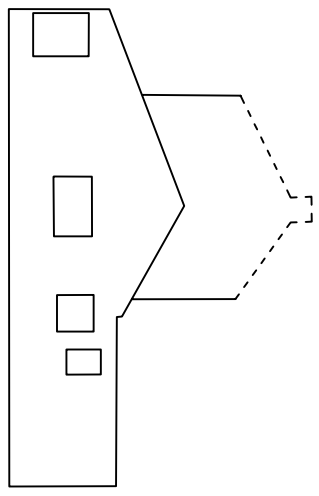
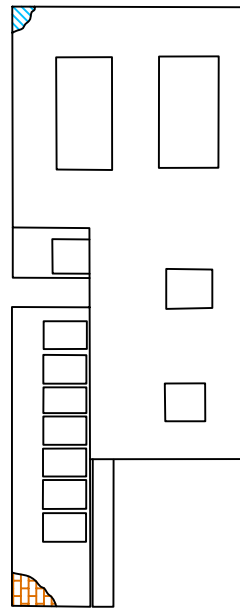
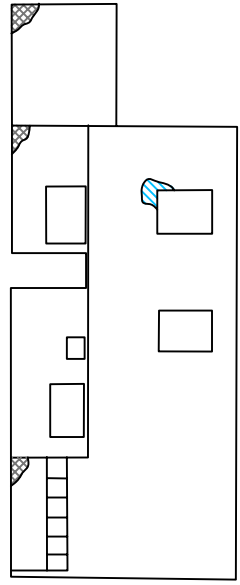
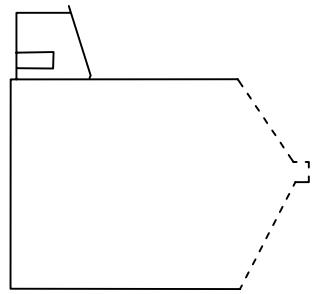
Figure 17: Elevations of main buildings at Stone Bridge Complex

South Facing Elevation (without extension)

North Facing Elevation (without extension)

East Facing Gable Wall (showing extensions)

South Facing Elevation (showing extensions)

North Facing Elevation (showing extensions)

West Facing Gable Wall (showing extension)
