KINNEGAD – ENFIELD - KILCOCK

**ARCHAEOLOGICAL
CONSULTANCY SERVICES
CONTRACT 1**

Archaeological Excavation
At Rossan 1
Clonard
County Meath
Licence Number 02E0866

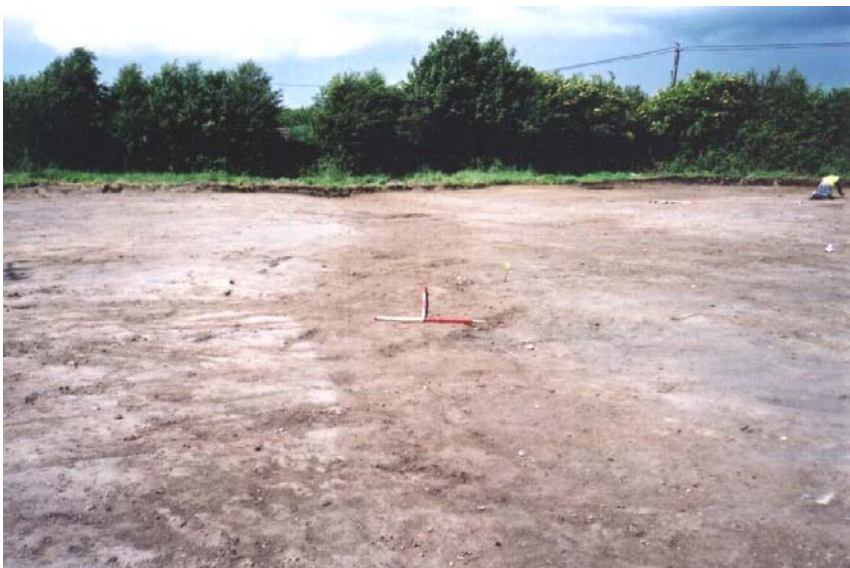
Plate 1: F1 from south.

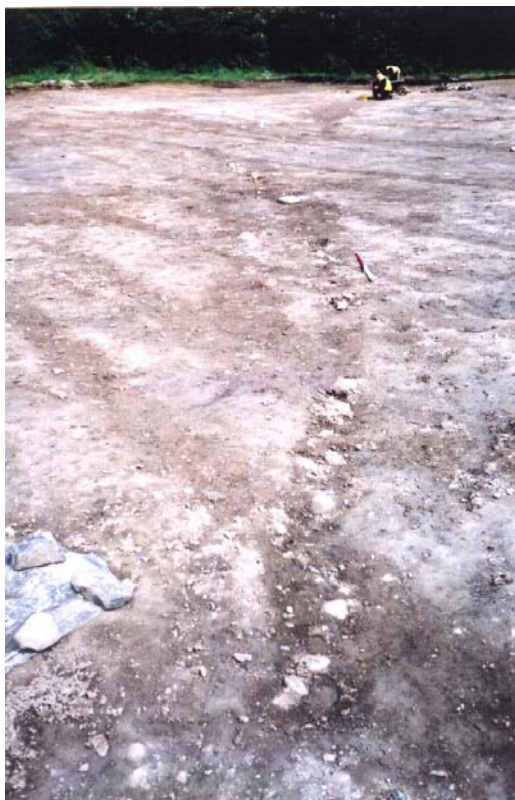
Plate 2: Cultivation furrows and
field drain from southwest.
(01_80:Rossan 1:CP2:26)

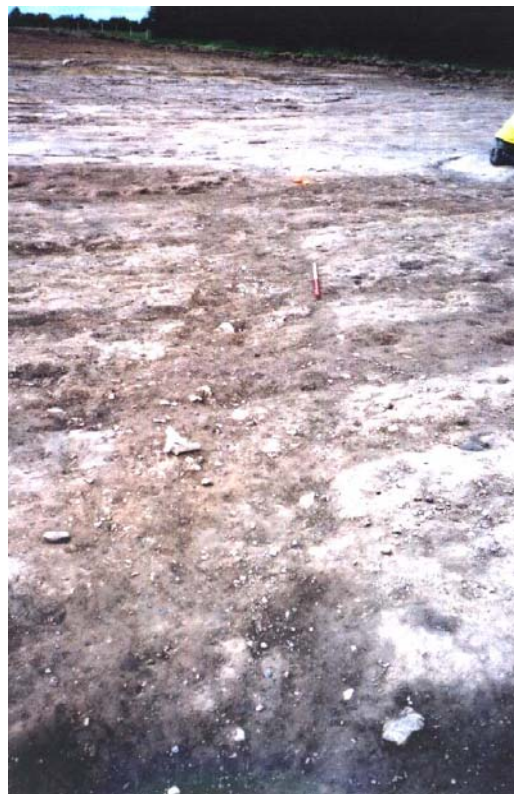
Plate 3: F11 and cultivation furrows from east-
southeast.

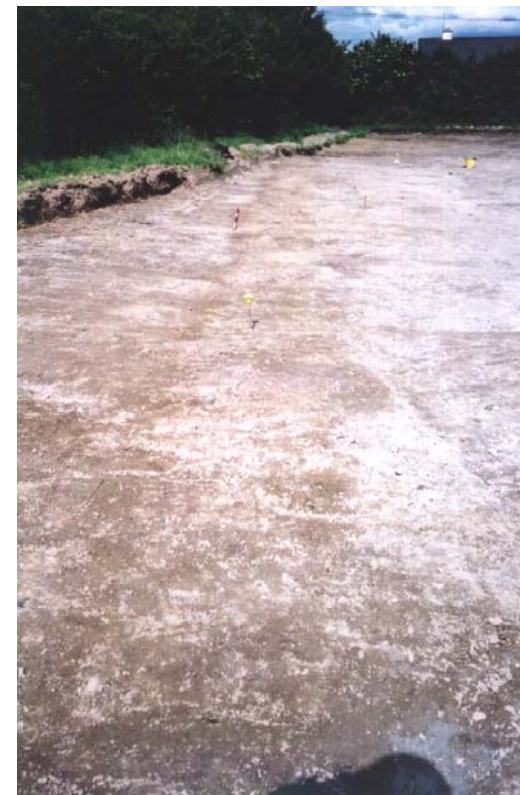
Plate 4: F2 from west-southwest.

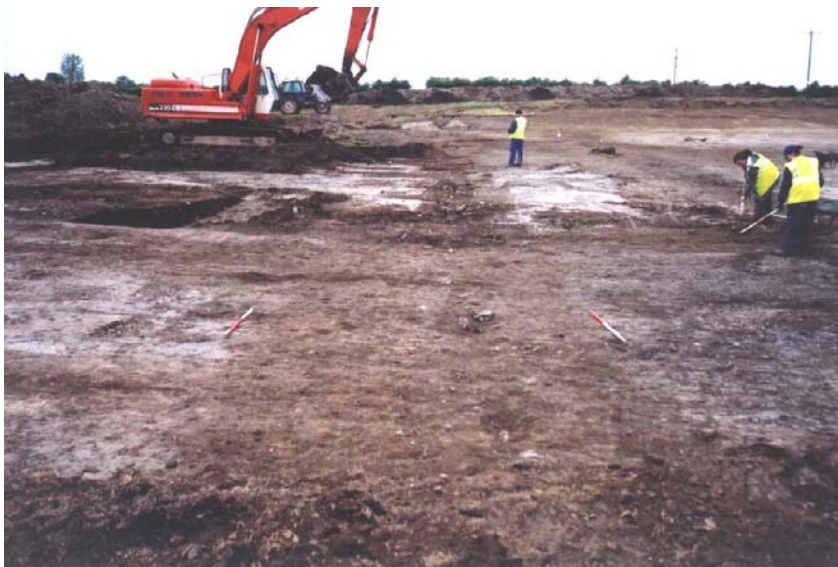
Plate 5: F103 and F104 from east.
(01_80:Rossan 1:CP4:8)

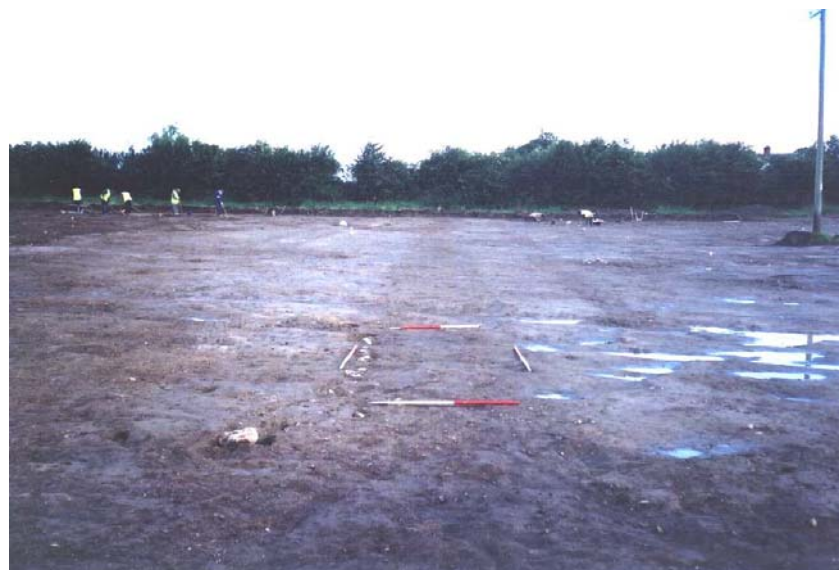
Plate 6: F16 from east.
(01_80:Rossan 1:CP4:16)

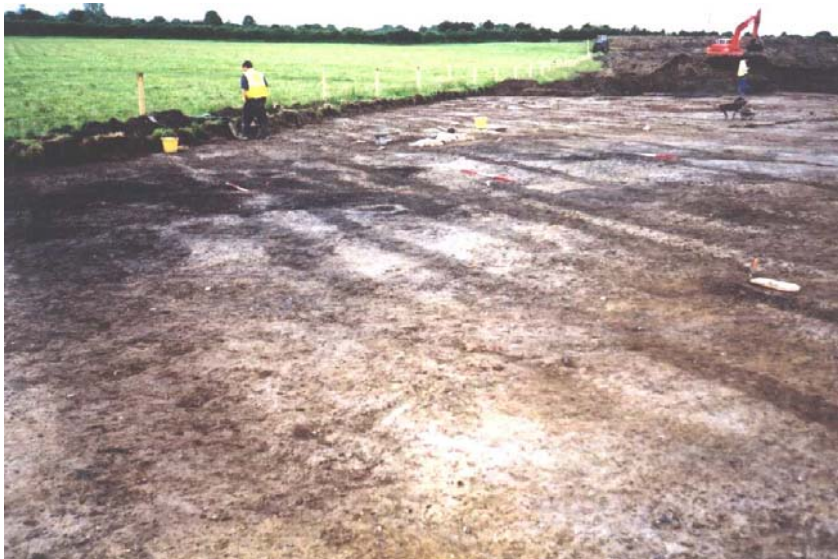
Plate 7: General view of south eastern area of site, from east.
(01_80:Rossan 1:CP4:25)

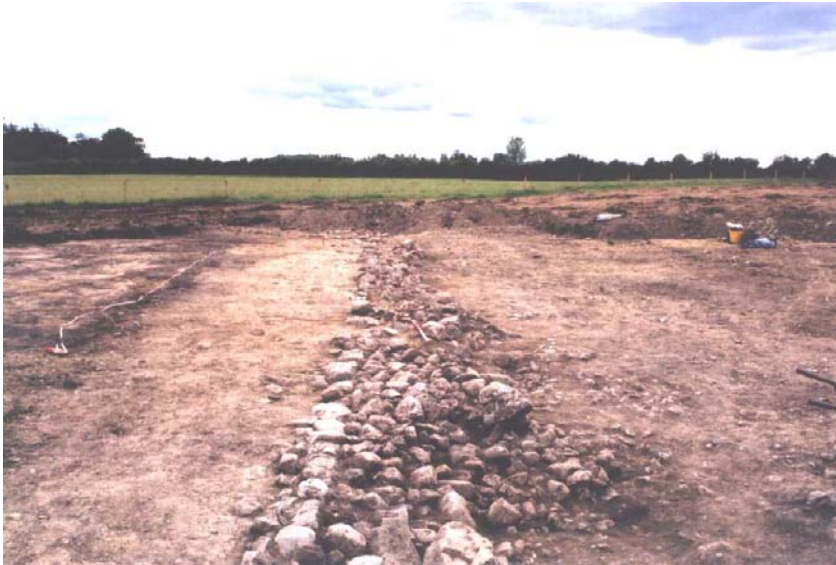
Plate 9: F148 from east.
(01_80:Rossan 1:CP6:11)

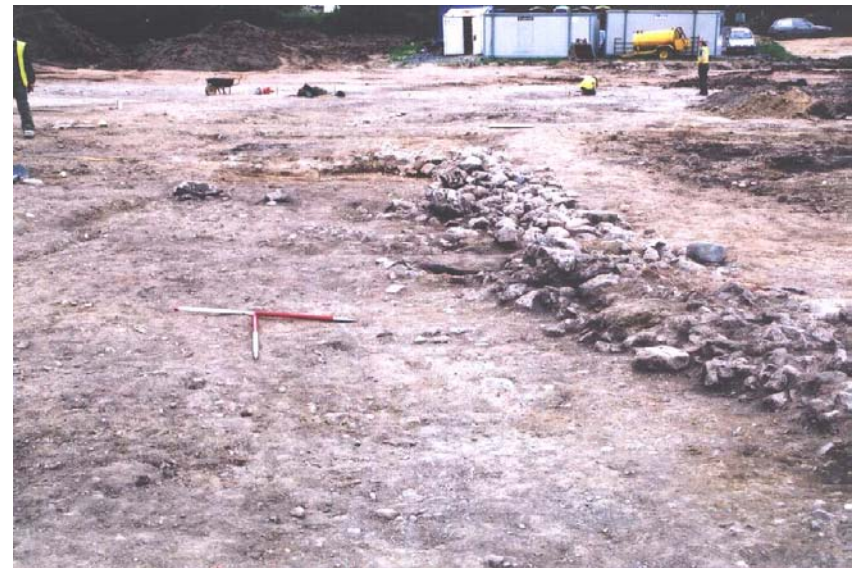
Plate 10: F148 from west.
(01_80:Rossan 1:CP6:17)

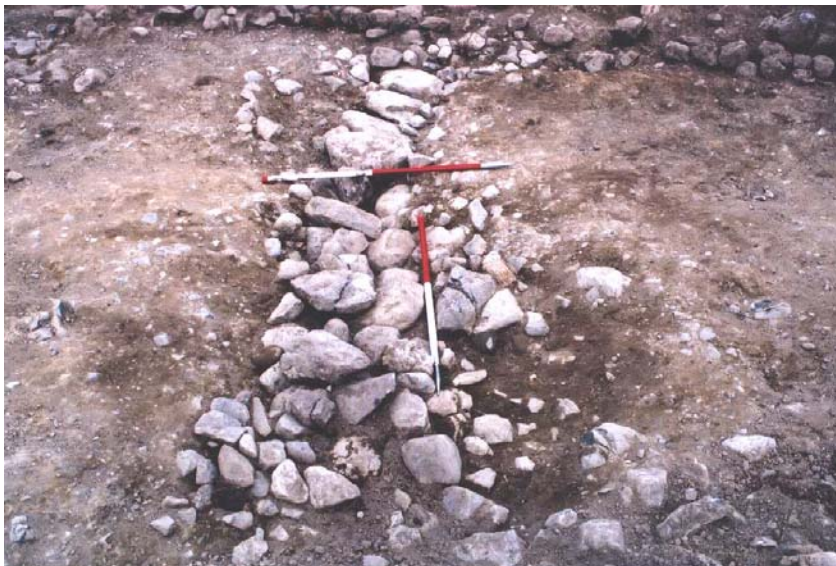
Plate 11: F152 from west.
(01_80:Rossan 1:CP6:26)

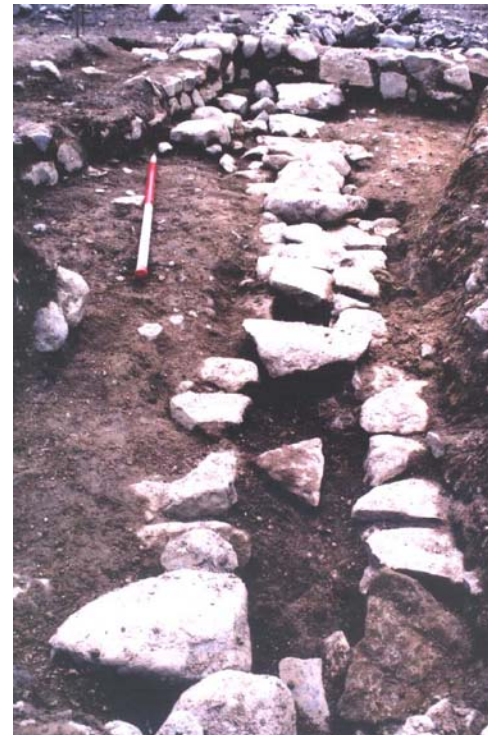
Plate 12: F207 covered drain from
northwest.
(01_80:Rossan 1:CP9:18)

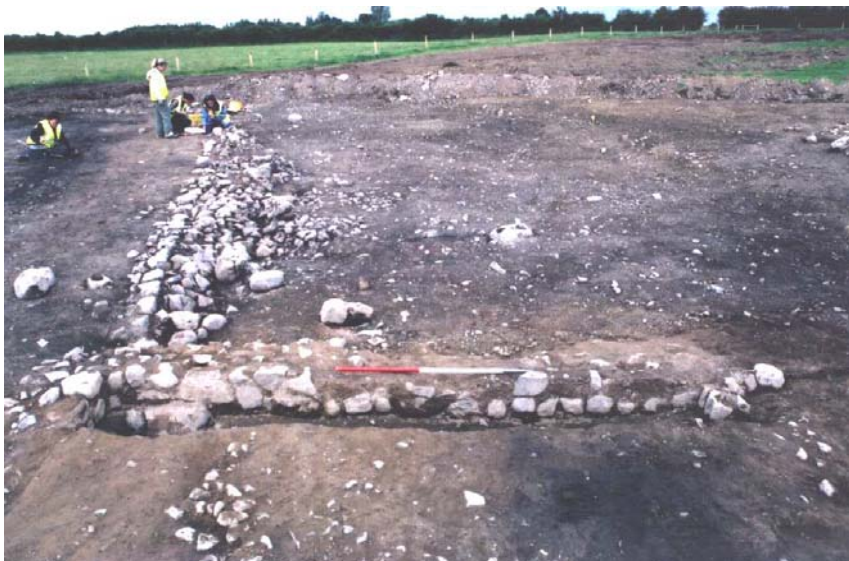
Plate 13: Remains of 1836-7 structure from northeast.
(01_80:Rossan 1:CP9:12)

The area tested exposed many potential archaeological features but through excavation the majority were found to be modern in character. The features found in this area of Rossan 1 tie in with the structures, the laneway and the field boundaries marked on the 1836–37 Ordnance Survey map.

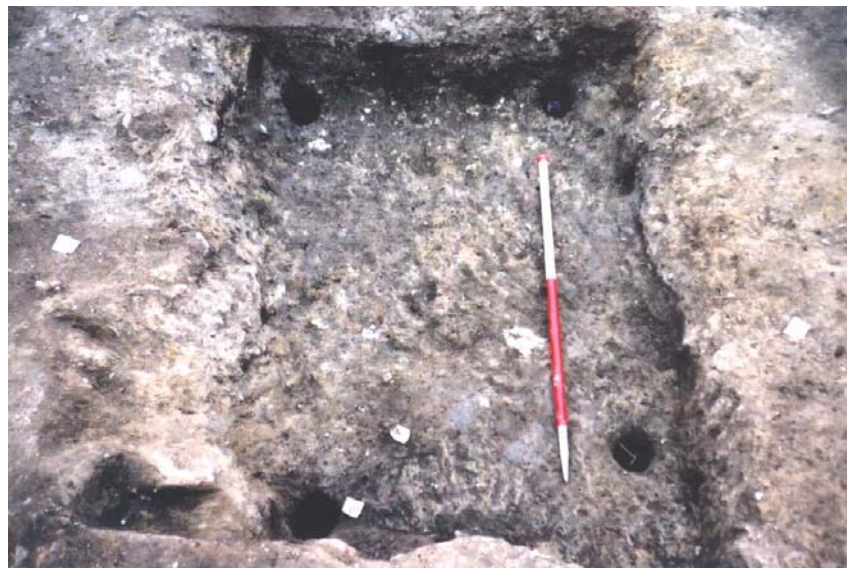
Plate 14: F132 from west, showing stakeholes.
(01_80:Rossan 1:CP7:28)

Two possible troughs were discerned in the southeastern area of the site: cuts **F132** and **F138**, both of which were subrectangular. **F132** measured 1.98m north to south by 1.24m east to west and was 0.17m deep. It had a sudden break of slope at the top, near vertical sides and a sudden break of slope to an irregular flat base. Its primary fill, **F139**, consisted of moderately-compact dark-brownish/black clayey sand containing frequent charcoal inclusions. This fill only occupied the southern end of **F132**, measured 1.24m east to west by 0.95m north to south and had a maximum thickness of 0.3m. A radiocarbon date of Cal BC 1100-790 was returned for this context. The secondary fill (**F110**) of the trough was hard grey sandy clay with moderate inclusions of charcoal. **F132** was cut by two east to west orientated linear features, **F89** and **F177**.

Seven possible stakeholes (**F188**, **F189**, **F190**, **F191**, **F192**, **F193** and **F198**) were cut into the base of F132. F188 was a subcircular stakehole in the northwestern corner of F132 with a diameter of 0.08m and a depth of approximately 0.41m. The top of the stakehole was slightly east in relation to the base at an angle of 89°. The break of slope at the top of F188 was sharp to gradual. Its sides were concave with some gentle widening midway and then tapered to a rounded point. It was filled with loose moderately-compact brownish-grey sandy clay (**F182**).

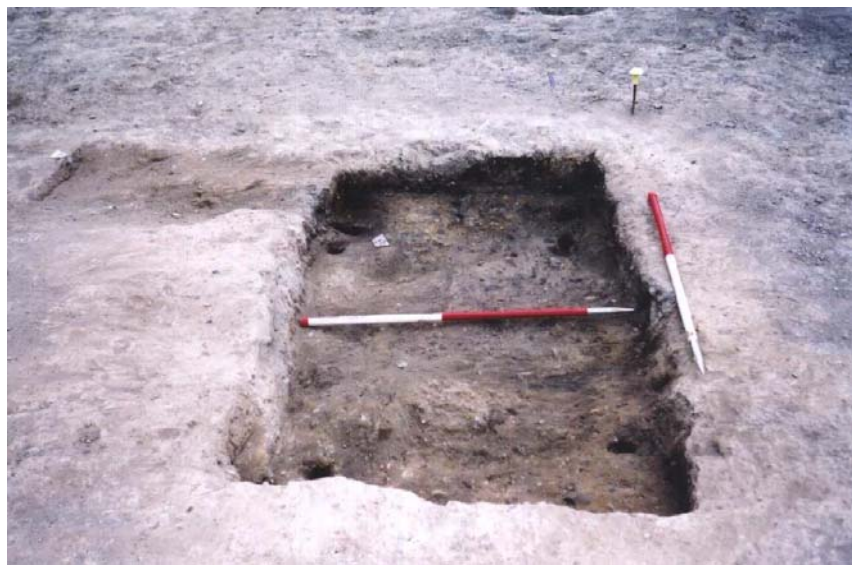
Plate 15: Detail of F132 showing small stakeholes in base.
(01_80:Rossan 1:CP7:8)

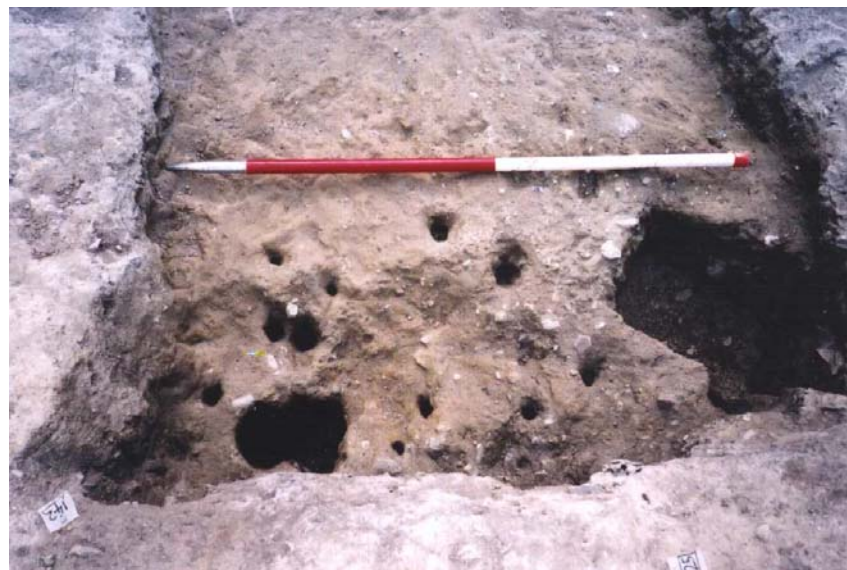
Plate 16: F138 from north.
(01_80:Rossan 1:CP8:20)

The second possible trough, F138, was subrectangular in plan and had rounded corners. It measured 1.52m north to south by 1.95m east to west and had a maximum depth of 0.25m. The break of slope at the top was sudden at the east and west ends but was more gradual at the north and south ends; the sides of F138 were slightly concave. There was a slight annexe at the northwest corner of the pit which had dimensions of 0.37m north to south by 0.64m east to west and was 0.07m deep. F138 had two fills: **F111** and **F115**. F111 was the secondary fill of F138 and consisted of loose to moderately-compact mid-brown clayey sand with small pebble inclusions. It measured 1.52m north to south by 1.94m east to west and was 0.2m deep. F115 was the primary fill of F138 and consisted of moderately-compact dark-brown clayey sand with moderate charcoal inclusions. It measured 1.3m north to south by 1.95m east to west and had an average depth of 0.075m. A radiocarbon date of Cal BC 1290-830 was returned for this context. F138 was cut by two east–west orientated cultivation furrows: **F109** and **F112**.

Four possible stakeholes were discerned in the base of F138, one at each of the four corners: **F140**, **F141**, **F142** and **F143**. All of them contained the same fill which was moderately-compact dark-grey clayey sand (**F135**). F140, located in the southwest corner of F138, was subcircular with a diameter of 0.13m and a depth of 0.43m. F141, located at the northwest corner of F138, was subcircular with a diameter of 0.11m and a depth of 0.29m. F142, located at the northeastern corner of F138, was a subcircular stakehole with a diameter of 0.12m and a depth of 0.32m. F143, located in the southeast corner of F138, was subcircular with a diameter of 0.13m and a depth of 0.32m. These four stakeholes had straight sides which tapered to a rounded base. Their inclinations of axis varied from 75 degrees (F143) to 86 degrees (F140). Cut into the east end of the base of F138 was a collection of twelve very small stakeholes (**F96**) all filled with F115. They varied in size from 0.12m to 0.05m (east to west), 0.08m to 0.05m (north to south) and were all 0.07m in depth. The break of slope at the top of these stakeholes was sharp, their sides were vertical and their bases were rounded.

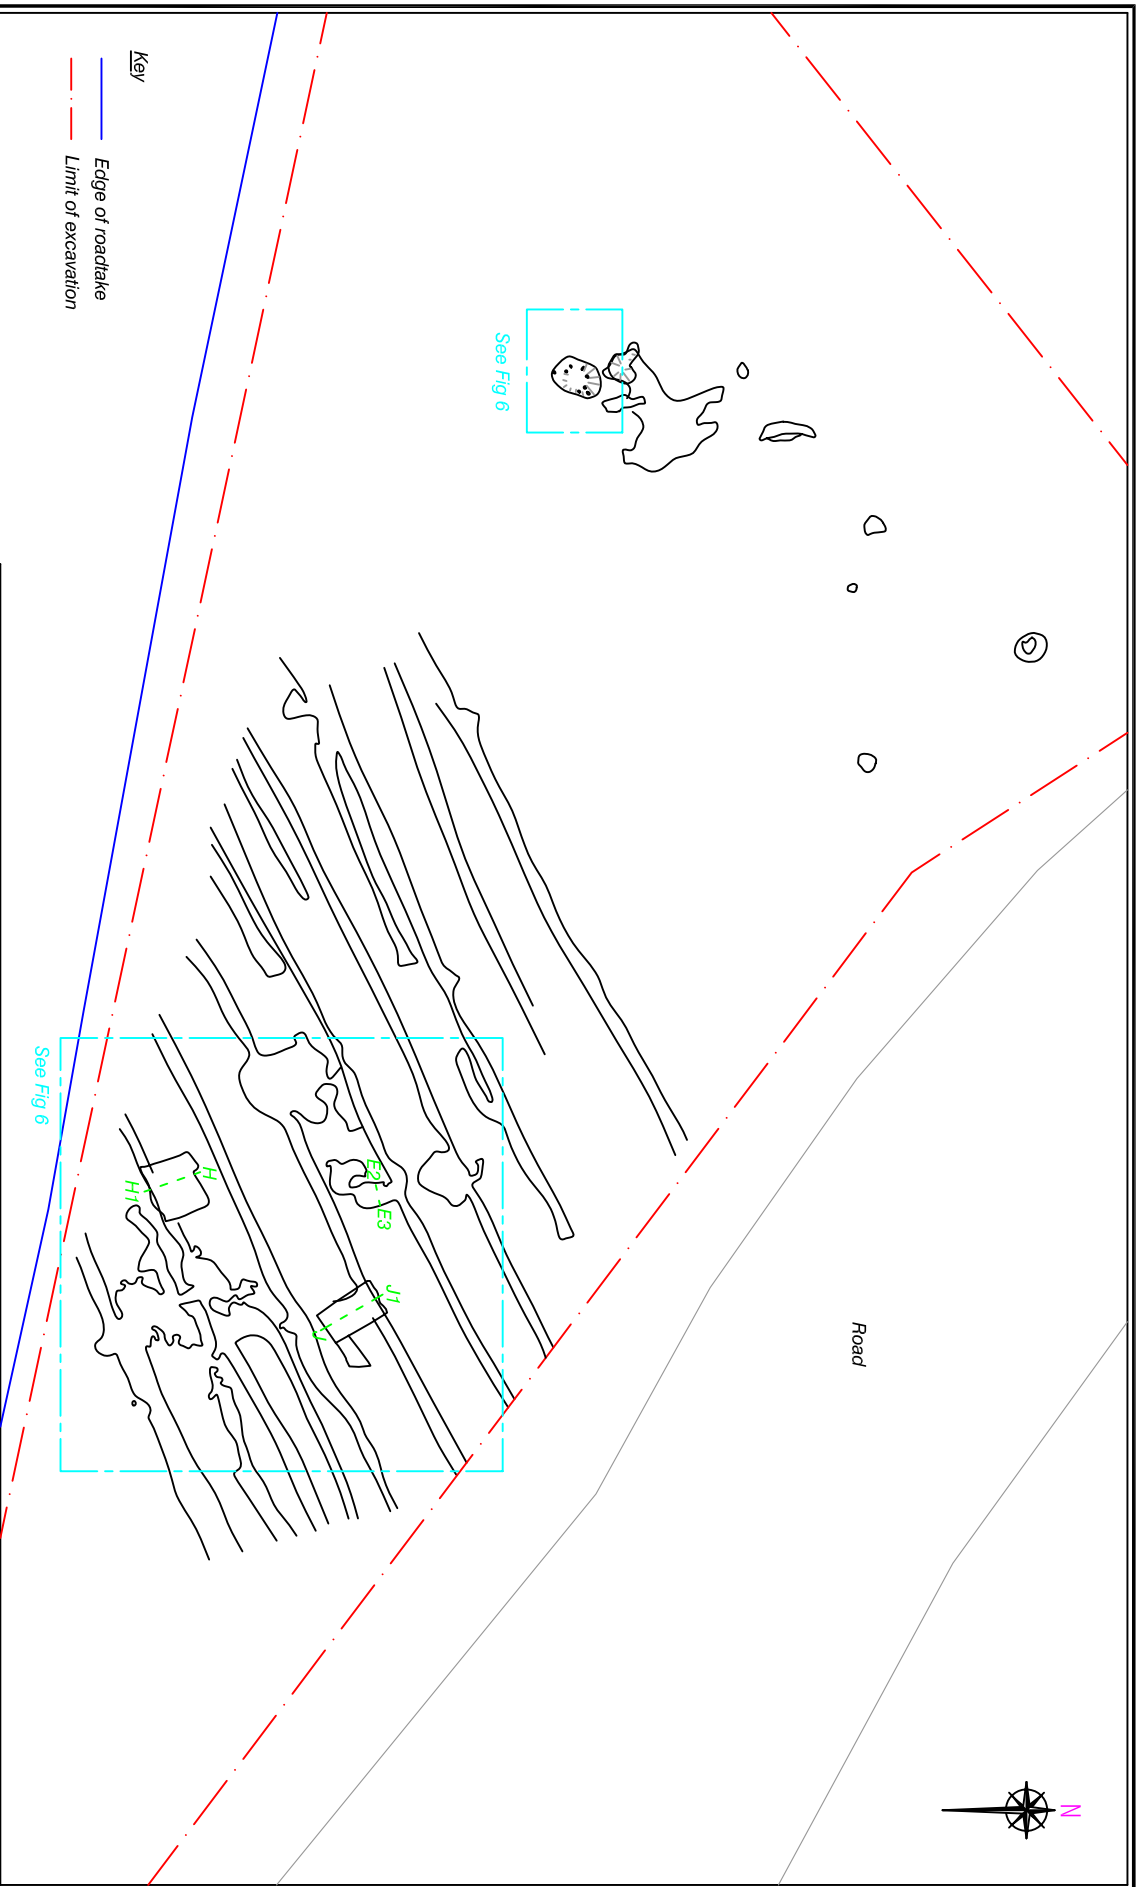
Figure 4: Detail of south eastern section of Rossan 1
