**N9/N10 Kilcullen to Waterford Scheme: Phase 3, Kilcullen to Carlow.  
Archaeological Services Contract No. 5 – Resolution, Kilcullen to  
Moone and Athy Link Road.**

**Final Report on archaeological investigations at Site E2877, in the  
townland of Ballymount, Co. Kildare.**

National Monuments Section Registration Number: E2877

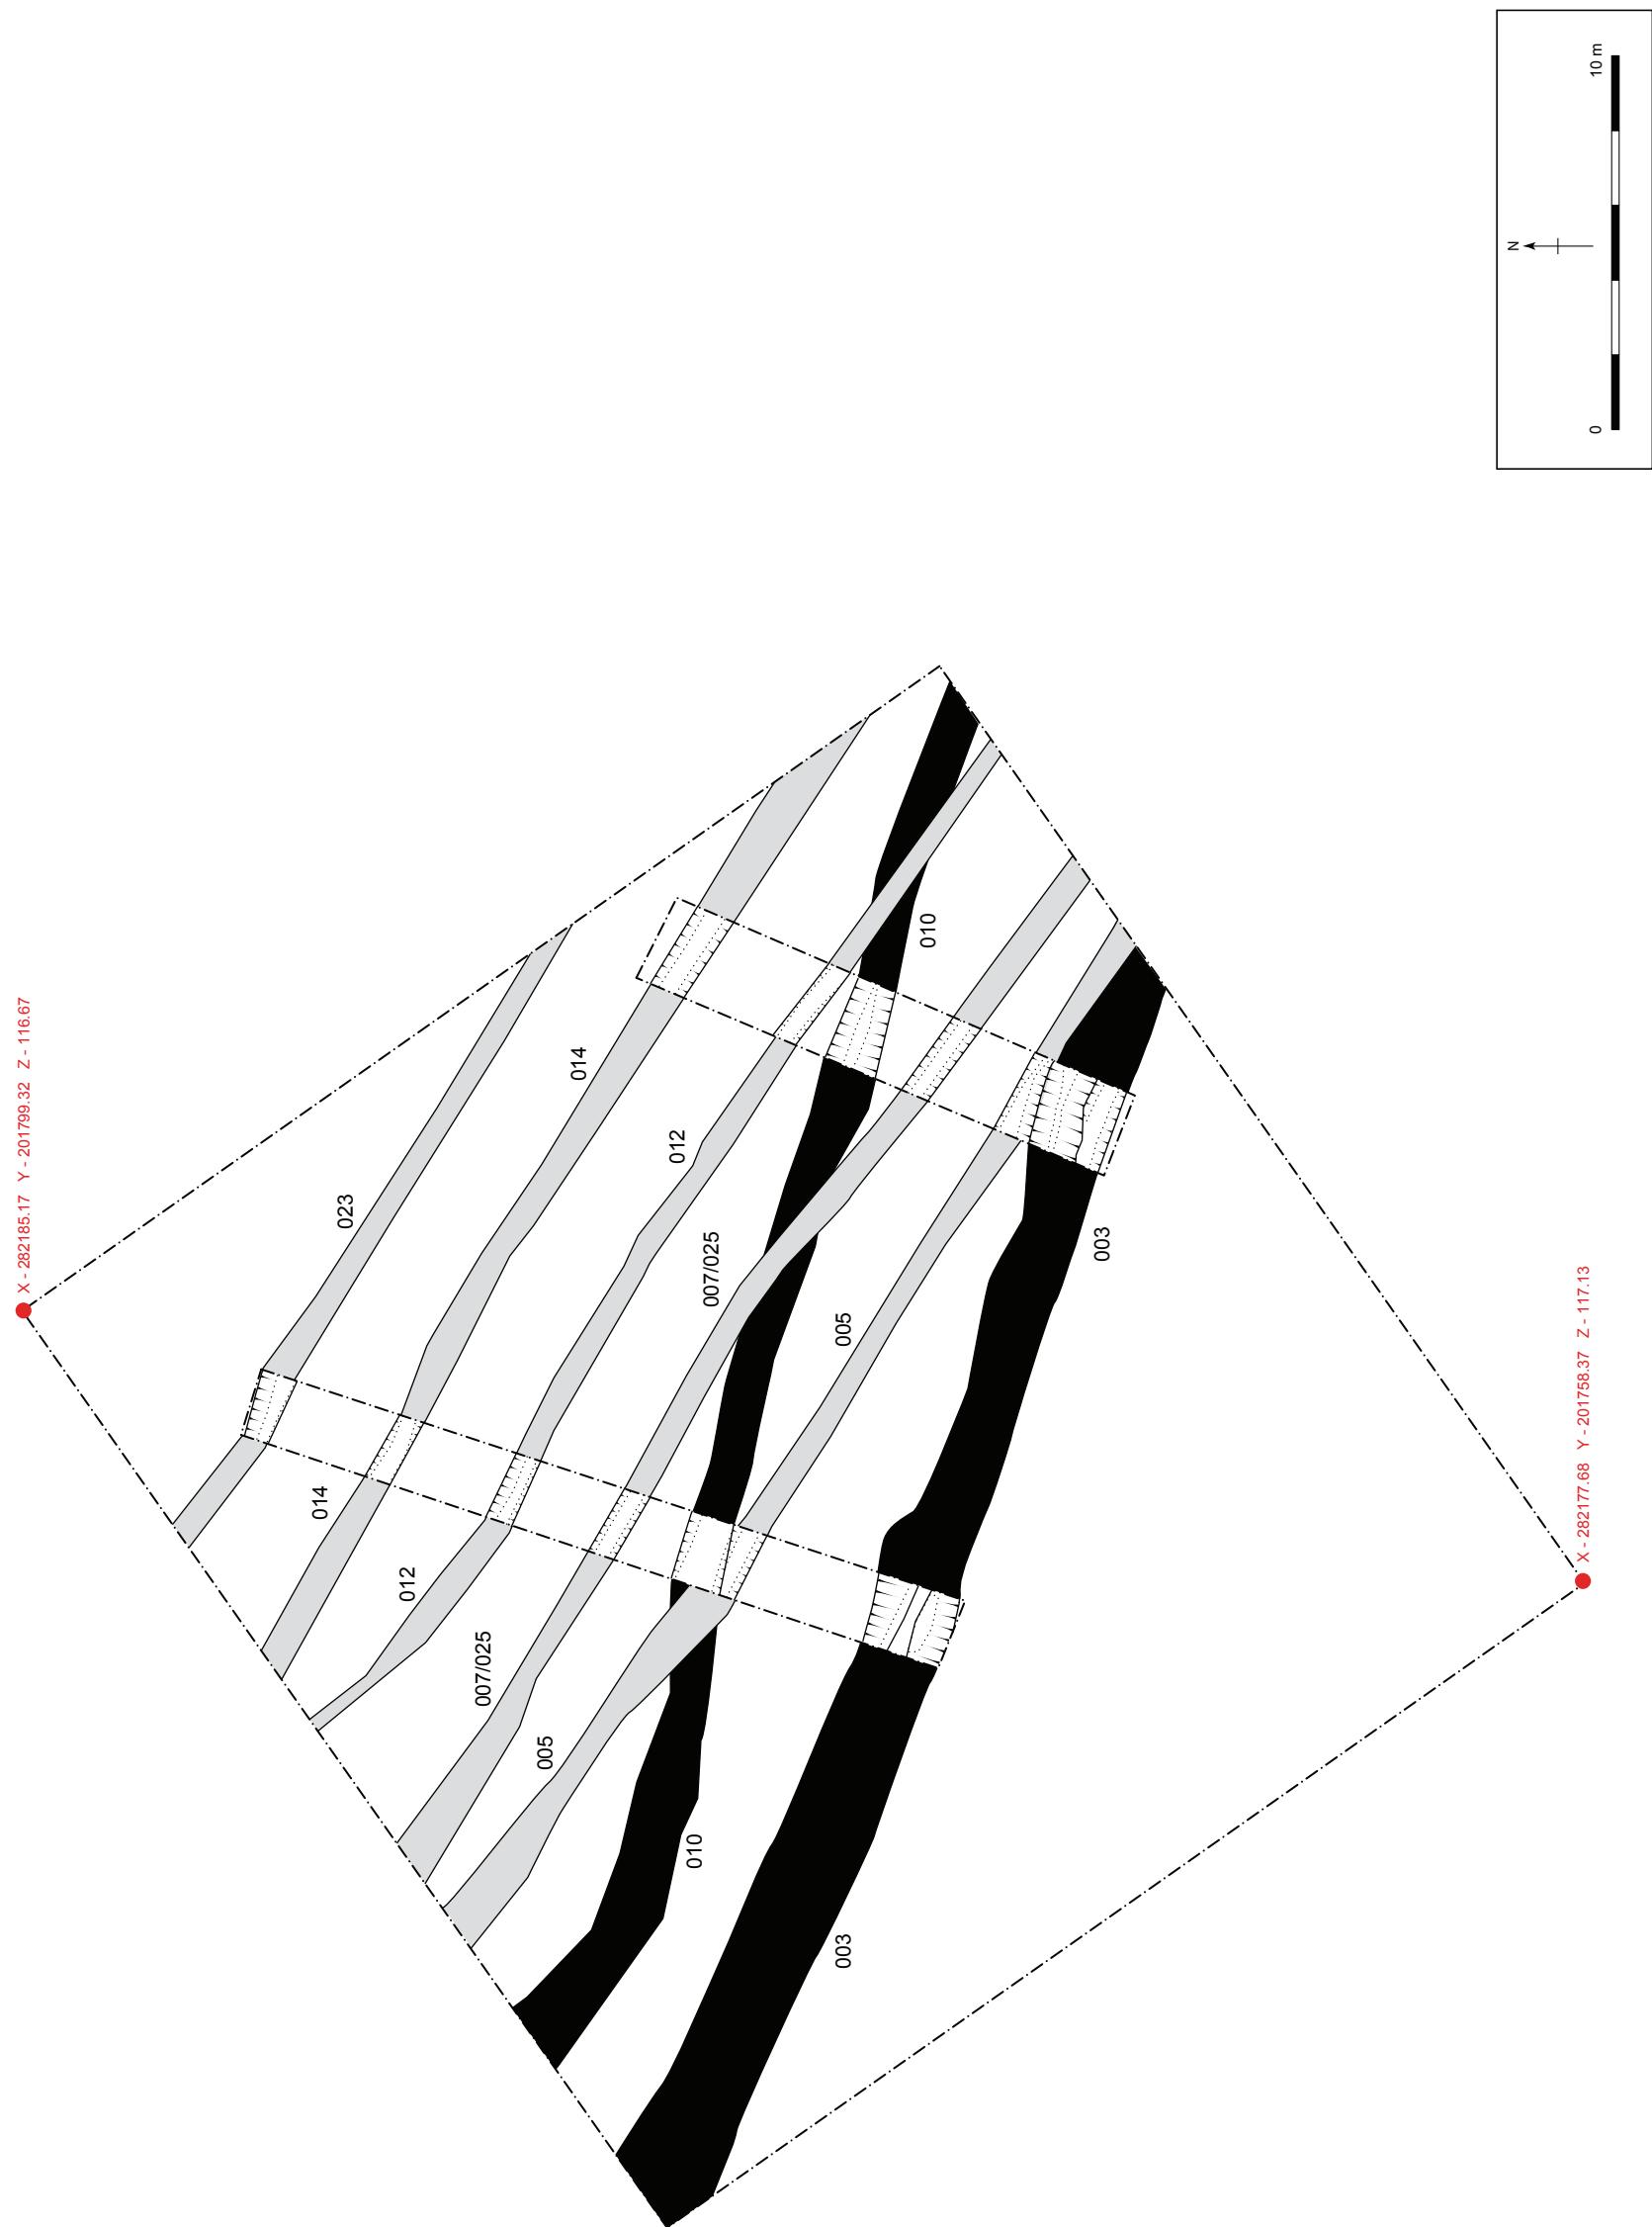
Figure 3 - N9/N10 Kilcullen to Waterford Scheme: Phase 3, Kilcullen to Carlow.  
Archaeological Services Contract No. 5 – Resolution, Kilcullen to Moone and Athy Link Road:  
E2877 site layout.

Following topsoil removal, two parallel linear ditches (003) and (010) were uncovered running in a west-northwest/east-southeast direction across the site with a distance of 3.5 m between them (Figure 3). A number of furrows were also discovered running over these linear ditches.

Five west-northwest to southeast orientated furrows where also identified running parallel to each other at a distance of 1.3 m apart (Figure 3). All had concave sides and flat bases. Furrow (005) cut across the ditch (003) and also the ditch (010). It measured 0.66 m in width and 0.12 m in depth and contained the fill (006) which was light greyish brown soft clayey sand.

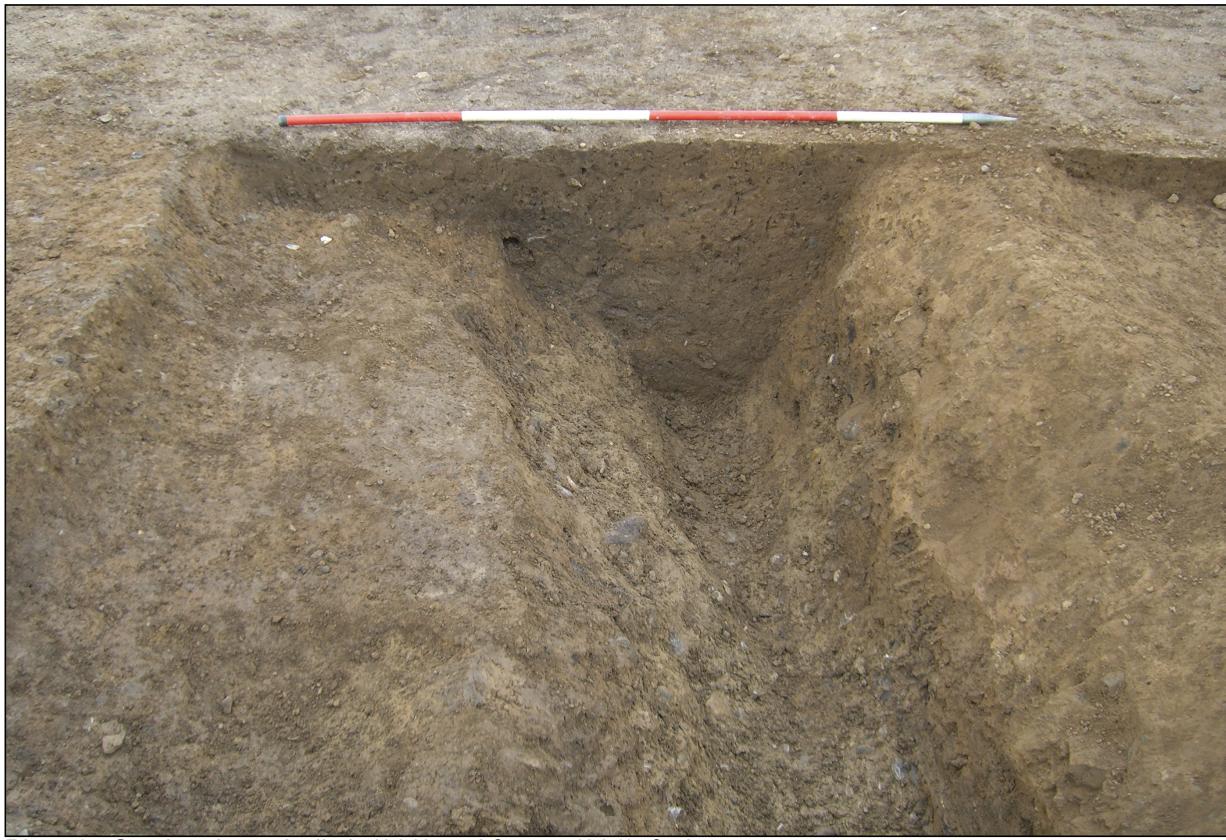
Plate 1 - Section through ditch (003) and furrow (021), facing east.

Linear ditch (003) (Plate 1, Figure 3) measured 1.4 m in width, 0.7 m in depth and extended beyond the CPO at its east-southeastern end and had a west-northwest/east-southeast orientation. It had sharp breaks of slope on top, gradually sloping sides, and a concave base with gradual breaks of slope. It contained a basal fill (020) which consisted of mid-brownish grey loose silty sand with charcoal inclusions and small animal bone fragments (E2877:001), and had a depth of 0.35 m. Overlying context (020) was deposit (019) which filled the majority of the ditch. It measured 1.4 m in width and 0.3 m in depth and was dark greyish brown loose silty sand with a horizontal lens of charcoal which ran through the fill. The upper fill of the ditch (004) consisted of silty sand with only occasional charcoal inclusions and had a depth of 0.20 m. Two pieces of post-medieval, probably 20<sup>th</sup> century pottery were found in this fill (E2877:004:001) and (E2877:004:002). To the southern side of this ditch was a later recut (021). It ran directly along the southern side of the ditch (003), measuring 0.75 m in width, 0.3 m in depth and also extended beyond the CPO at its east-southeastern end. This contained a single fill (022), mid-brownish grey hard clayey sand. This was probably a drainage ditch or an attempt to re-establish linear ditch (003).

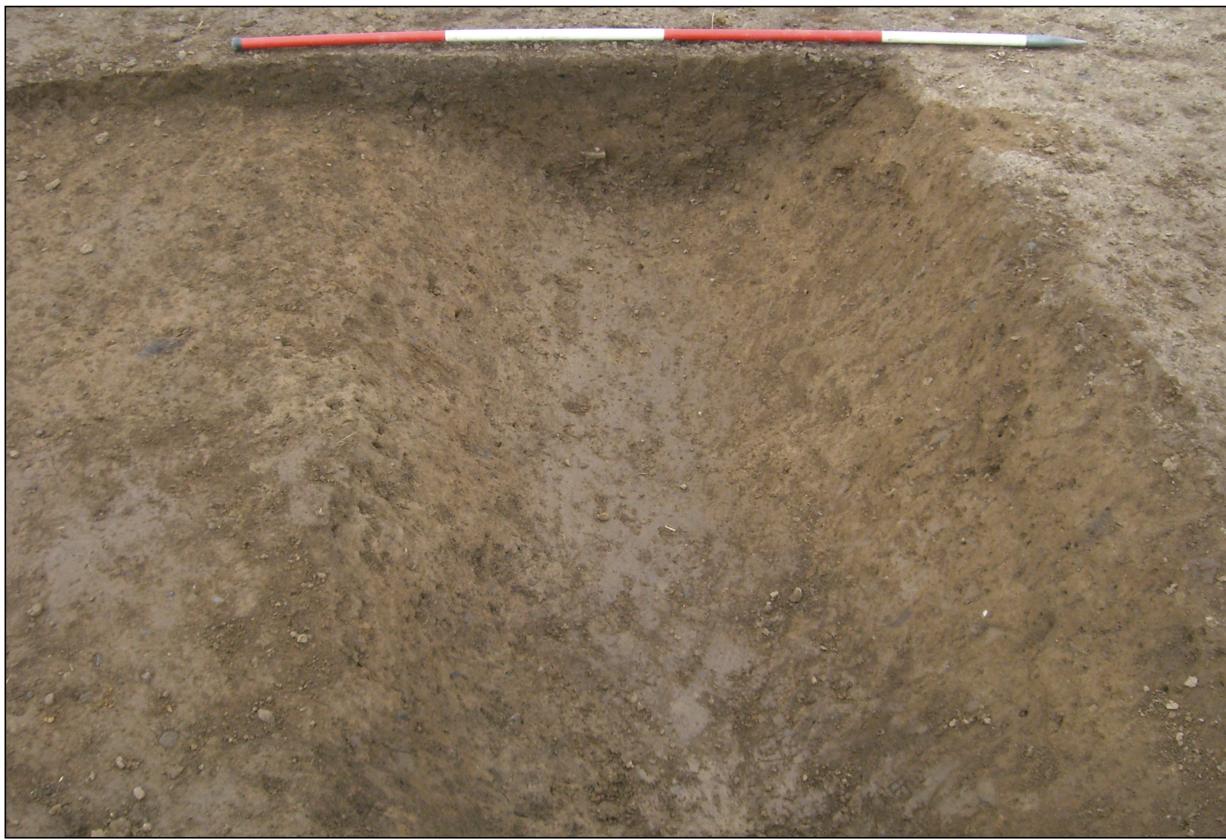
Plate 2 - Section through ditch (010), facing east

Situated 5 m to the north of linear ditch (003), and running roughly parallel to it, was a linear ditch (010) (Plate 2, Figure 3). This extended beyond the CPO at its east-southeastern end and had a west-northwestern/east-southeastern orientation and measured 1.6 m in width and 0.63 m in depth. It had gradual breaks of slope, gradually sloping sides and a rounded base. The basal fill (018) was mid-greyish brown hard sandy clay with occasional small stone inclusions. It measured 1.3 m in width and 0.4 m in depth and ran the entire length of the ditch (010). Overlying fill (018) was fill (011) which measured 1.55 m in width and 0.2 m in depth. It was mid-brownish grey hard clayey sand with occasional small stone inclusions. It also contained a post-medieval iron hook (E2877:011:001) and animal bone (E2877:002). This ditch was cut into the natural but at the east-southeastern end it was cut into a subsoil layer (009), which was a loosely compacted mid brown clayey sand with occasional inclusions of small stones, measuring 1.45 m in width and 0.13 m in depth.

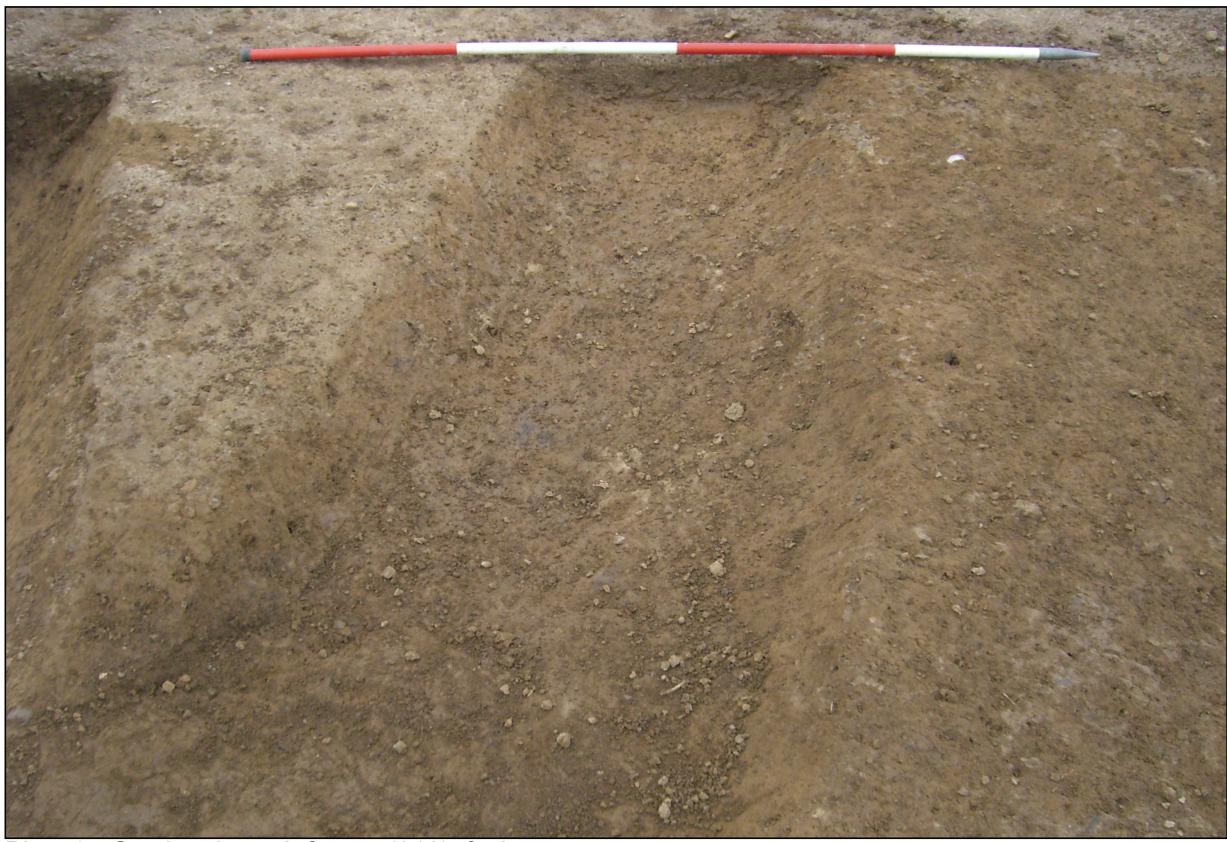
Plate 3 - Section through furrow (012), facing east.

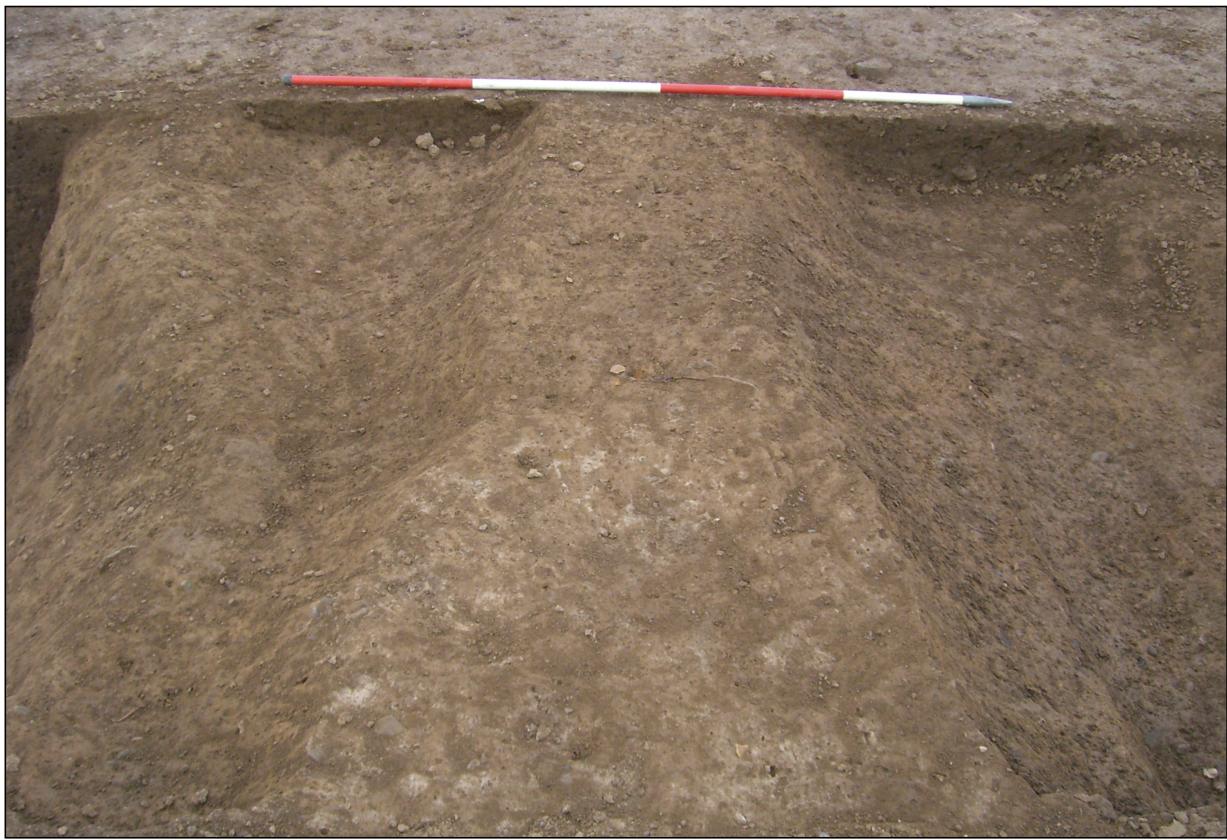
Plate 4 - Section through furrows (005) and (007), facing east.

Furrow (007)/(025) ran parallel to (005) (Plate 4) at a distance of 2.5 m. It measured 0.65 m in width and 0.25 m in depth. It contained the fill (008)/(026) which was mid-greyish brown soft clayey sand which contained some small stone inclusions. Furrow (007)/(025) cut a possible earlier drain/furrow (016); it measured 0.17 m in depth, 0.3 m in width and contained the fill (017) which consisted of mid-brownish grey compact silty sand. It was only visible for 1 m and may only have been a drainage feature. Furrow (012) ran parallel to furrow (007)/(025) at a distance of 2.5 m to the northeast. Furrow (012) (Plate 3) measured 0.85 m in width, 0.16 m in depth and contained the fill (013) which consisted of light orangey brown hard clayey sand. Furrow (014) ran parallel to the furrow (012) at a distance of 2.5 m to the northeast. Furrow (012) cut linear ditch (010). Furrow (014) measured 0.83 m in width and 0.13 m in depth and contained the fill (015) which consisted of light orangey brown hard clayey sand. Furrow (023) ran parallel to the furrow (014) at a distance of 2.5 m to the northeast. The furrow (023)
