Archaeological Report 11E0055

Excavation and Testing

N59 Road widening scheme at Knockbreaga,
Knockloughra and Carrowbeg (Fergus), Co Mayo.

Excavation Report

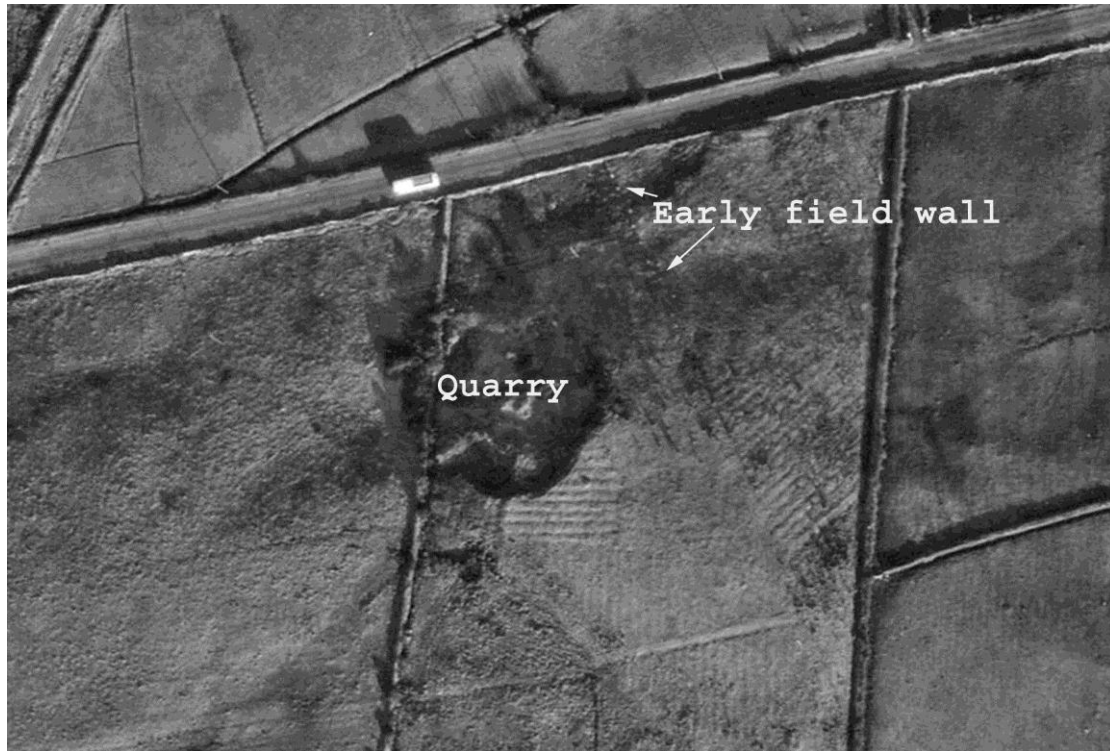
Figure 2 Detail of excavation area from aerial photo (Fig.1) showing the field wall and quarry.

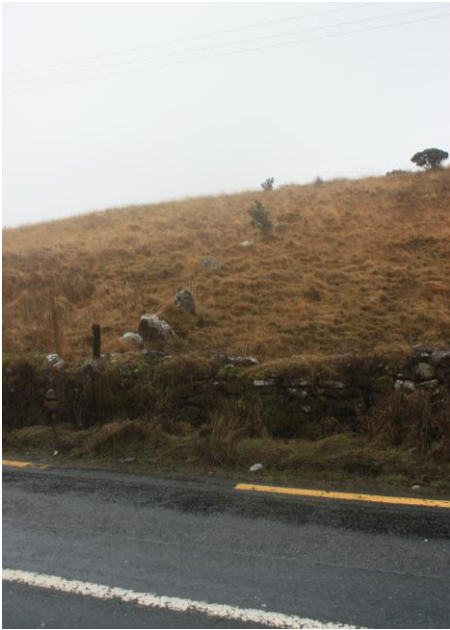
Figure 3 Looking south to the early and later field walls

This denuded wall consists of relatively large upright boulders aligned NNW/SSE. It runs from the existing road boundary wall, south up a moderately steep, north facing drumlin slope. At c. 60 m it runs into a low linear bank which continues to the top of the drumlin and turns sharply to the west at the hill top.

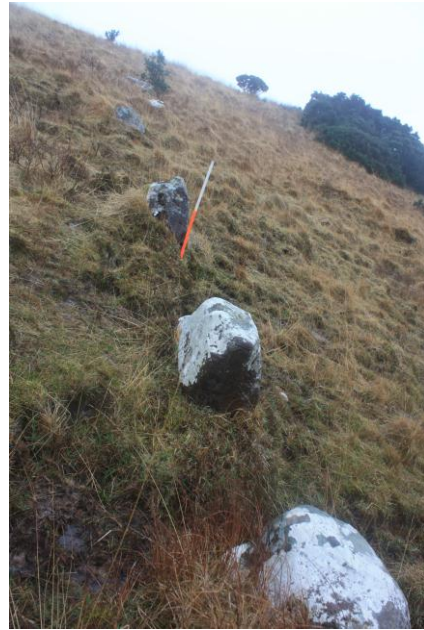
Figure 4 Looking south to the early field wall.

This wall may be the remains of a boundary wall marked on the first edition OS six inch scale map (See attached) and is of unknown date. Most of the walls in the area postdate the first edition OS maps, are generally aligned NS/and EW and are of different construction i.e. built with smaller stones, laid horizontal, with no larger vertical boulders noted. The majority of the early wall is outside the development area and as such will be preserved *in-situ*.

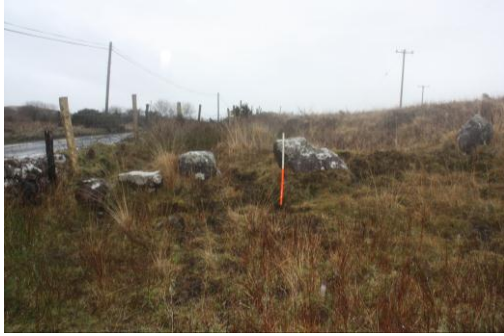
Figure 5 Pre-excavation view of the test area, looking west.

The 5m length of wall, which was tested, was located immediately south of the northern field boundary wall. This section consisted of three upright boulders which were roughly 0.1m apart and 0.1m from the northern boundary wall. One additional, larger boulder was set 0.7m further south, in line with the previous boulders. The boulders ranged in size from 0.58m by 0.60m by 0.30m to 1.1m by 0.45m by 0.6m. All of the boulders were naturally rounded with no evidence for modification and were set upright, resting on topsoil and the surface of the subsoil. There was no evidence for foundations or any ground preparation for securing the wall in place. Smaller stones identified on either side of the boulders were probably used to fill the gaps between the boulders and formed part of a more substantial wall when complete.

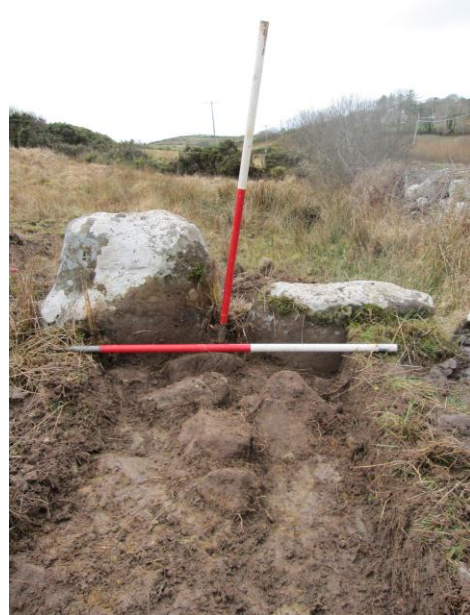
Figure 8 Looking west to trench 1 showing the displaced stones resting on the subsoil.

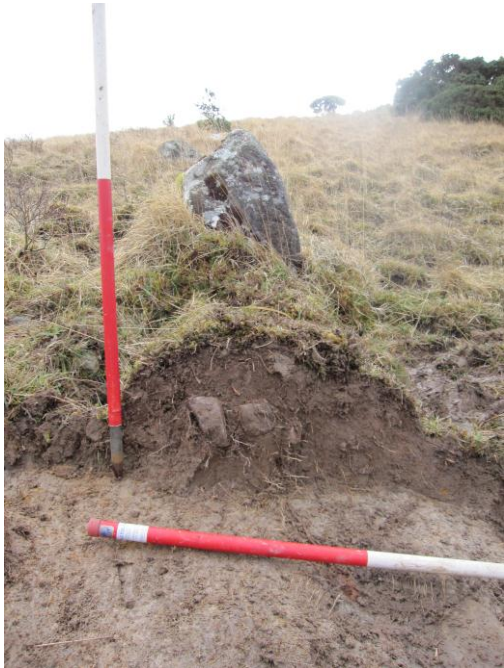
Figure 6 South side of trench 1 showing the early field wall in section.

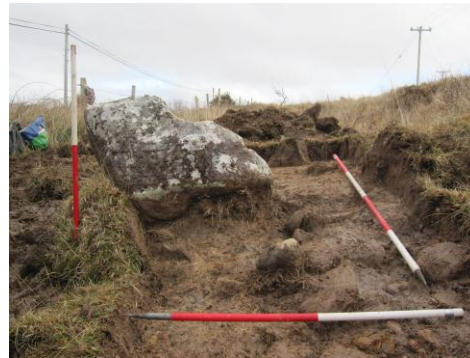
Figure 9 Looking east to trench 1 showing one of the boulders resting on sod and subsoil.

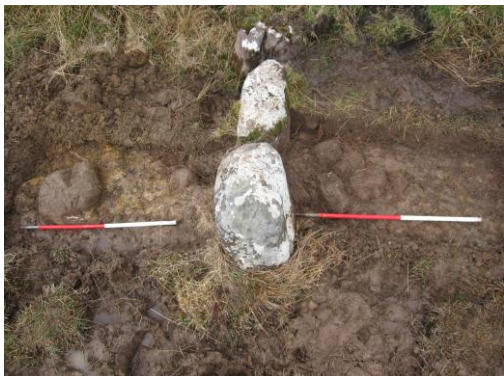
Figure 7 Trench 2 showing the field wall and displaced stones to the east and west

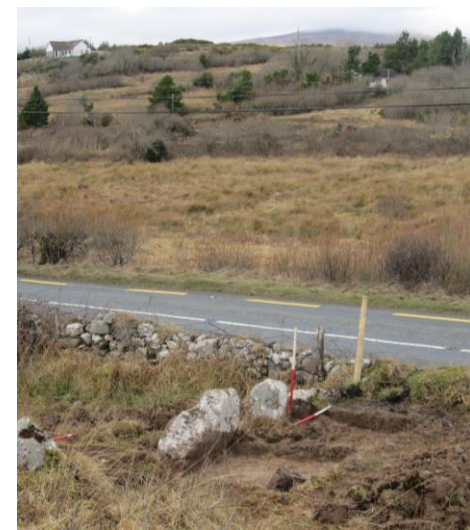
Figure 10 General view of the excavation looking northwest.

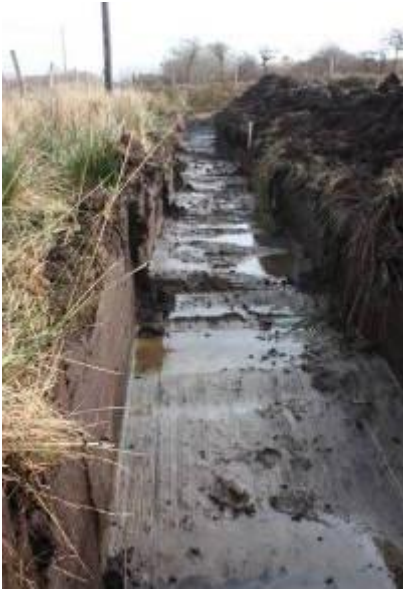
Field 1: This trench was located 2-3m from the northern field boundary, was 1.9m wide by 75m long. The eastern half of the trench cut through a waterlogged hollow and was excavated to a depth of 0.8-1.0m. Its eastern end was cut by a modern stone filled drain. The field was characterised by frequent rushes with 0.1-0.15 m of rooty sod resting on fine sticky silt and peat with occasional preserved natural wood. The subsoil in this area was a mid-grey daub rising to the west to a grey/orange-brown mottled boulderclay. The sod /topsoil to the west was 0.2m deep and rested directly on this boulderclay. A modern 0.3m wide machine trench cut through the test area into the subsoil to a maximum depth of 0.25m.

Figure 12 East end of field 1.

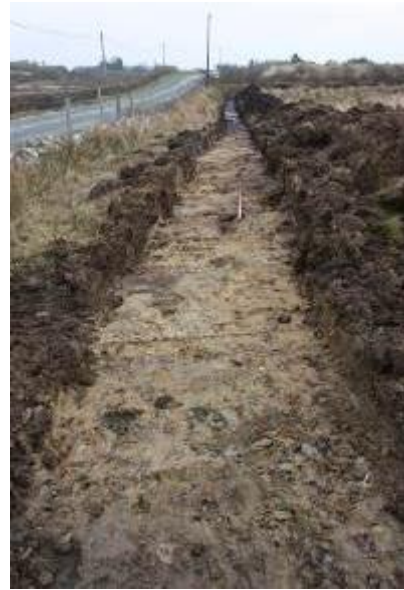
Figure 13 Looking east to field 1 test trench.

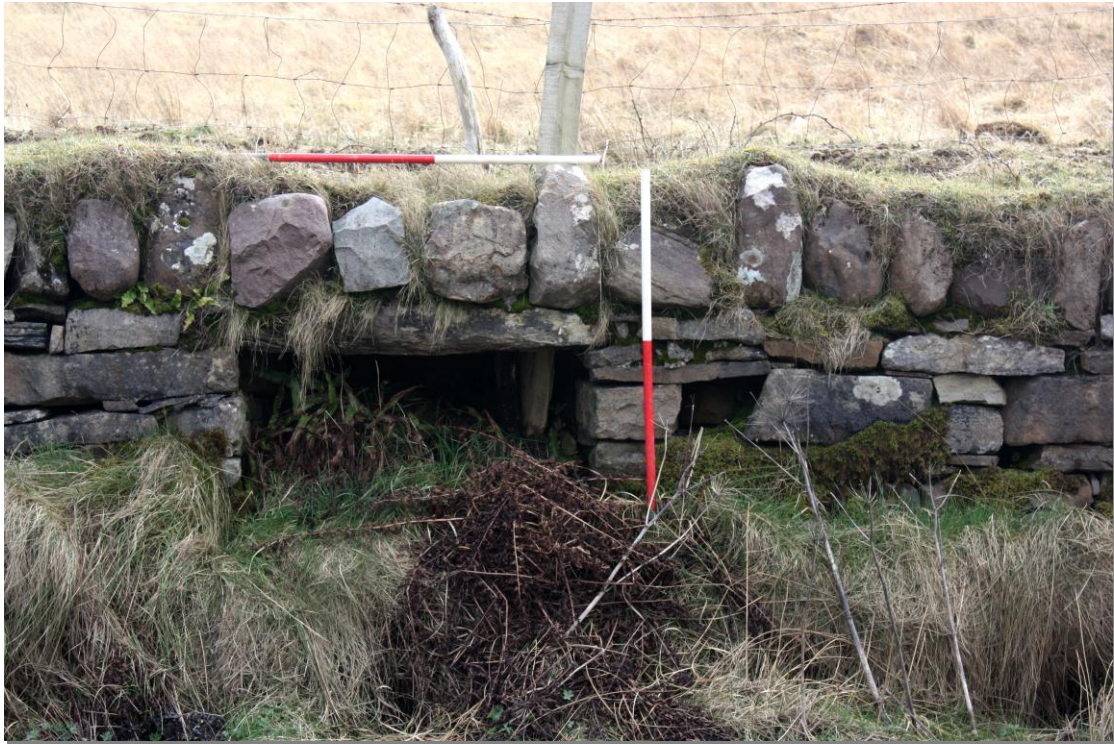
Figure 14 Looking south to the lime kiln incorporated into the field boundary at the road edge.

A lime kiln (Figs. 14-16) of probable nineteenth/twentieth century date was incorporated into the northern field boundary with the stokehole opening out onto the road. It is located 20m from the eastern field boundary. It was evidenced on the surface as a low sub circular mound 3.4m in diameter with a central hollow roughly 2m in diameter. This hollow overlay the kiln bowl which had a maximum diameter of 2m near the surface and is filled with loose stone, ash and charcoal. A linteled stokehole is incorporated into the field wall visible in its northern face. The wall is of roughly coursed local limestone with a large lintel (1.2m long by 0.1m thick) over the stokehole opening. Second lintel set back at a lower level is also visible. This opening is 1.06m wide and currently 0.5m high and is overgrown. A gap (0.22m by 0.22m) is located in the wall to the west side of the kiln and may be related to it.

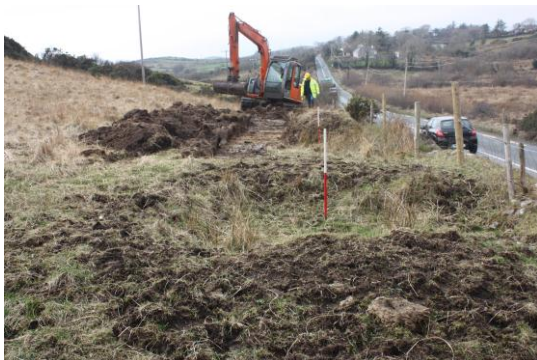
Figure 15 Looking west to the lime kiln within field 2.

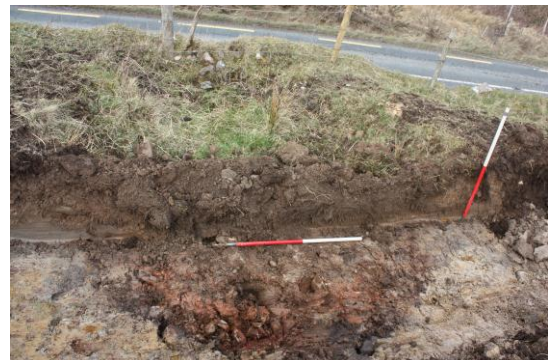
Figure 16 Exposed upper level of the lime kiln within field 2.

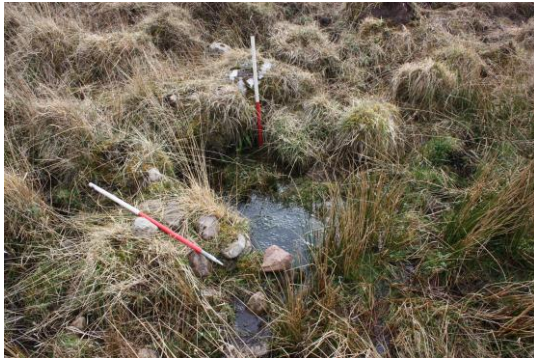
Figure 17 Water filled hollow in field 2.

Two crudely lined water filled hollows located in the same field are likely to be improvised drinking troughs for livestock or rough wells. They were located to the west of the hand test area 6-8m from the northern boundary field wall.

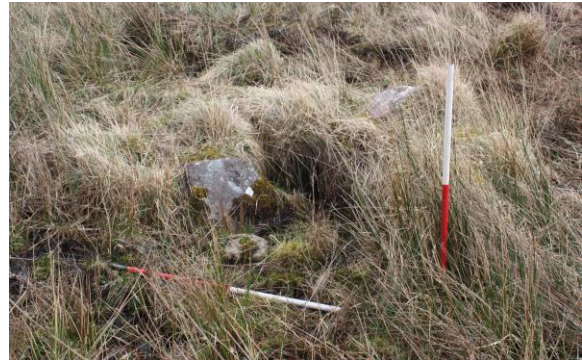
Figure 18 Second water filled hollow in field 2.

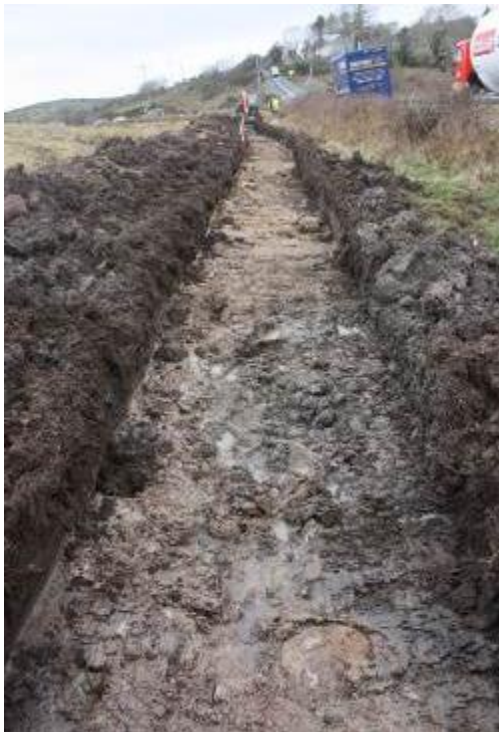
Field 3: This trench was located 2-3m from the northern field boundary, was 1.9m wide by 87 m long. The trench was generally excavated to a depth of 0.35-0.5m deep with 0.35-0.45m of sod and topsoil which was a fine silty clay turning to peat for the eastern western 20m. Peat in the eastern 20m reached a maximum thickness of 1m and rested on very stony subsoil. This stratigraphy continued east in field 4 and the lower part of the hollow is crossed by a stream. The stony subsoil may be the result of water action from an earlier course of the stream.

Figure 19 Field 3 looking west.

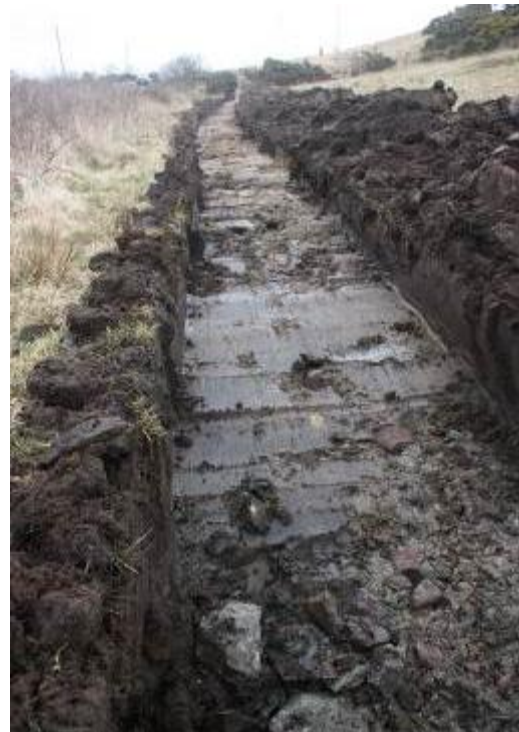
Figure 20 Field 3 looking east.

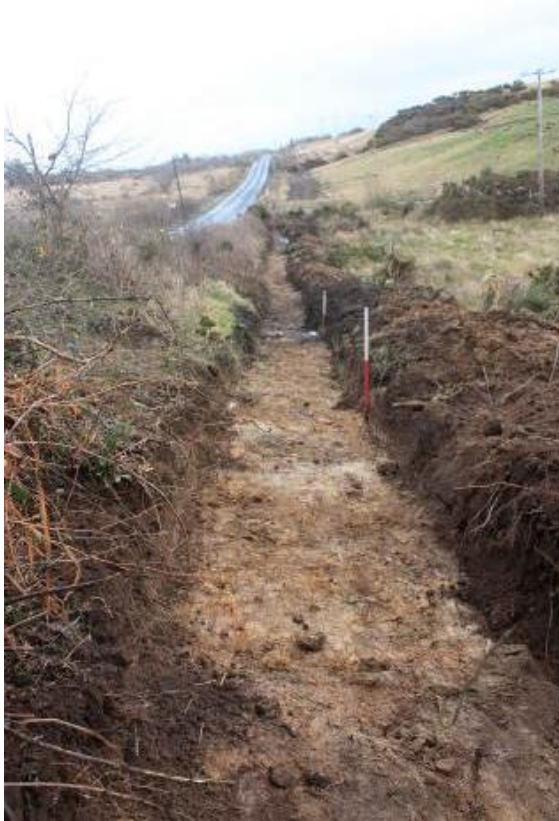
Figure 21 Looking east to field 4.

Field 4 & 5: The trench was located 2-3m from the northern field boundary, was 1.9m wide by 87 m long and had an overall length of 211m. The eastern 78m ran from the stream and side road to the eastern face of a moderate sized drumlin. The sod and topsoil, a silty peat with frequent roots, ranged in thickness from 0.4-0.8m on lower ground and was 0.2m thick on the hill top. This field was heavily overgrown with gorse, occasional trees and scrub vegetation. Topsoil in the eastern half of the trench, mostly in field 5 was very black and contained frequent rubble possibly from a demolished stone building, however there were no in situ remains present. A modern machine dug trench, containing a plastic pipe, cut the eastern 25m of the trial trench longitudinally and continued into the eastern field, field 6. Modern pottery and plastic was identified in the topsoil towards the centre of the trench indicating modern disturbance.

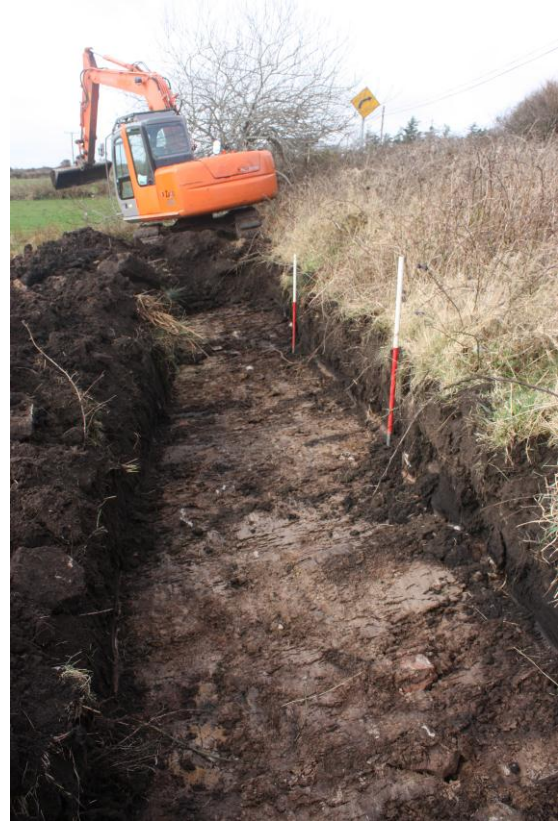
Figure 22 Looking west to field 5.

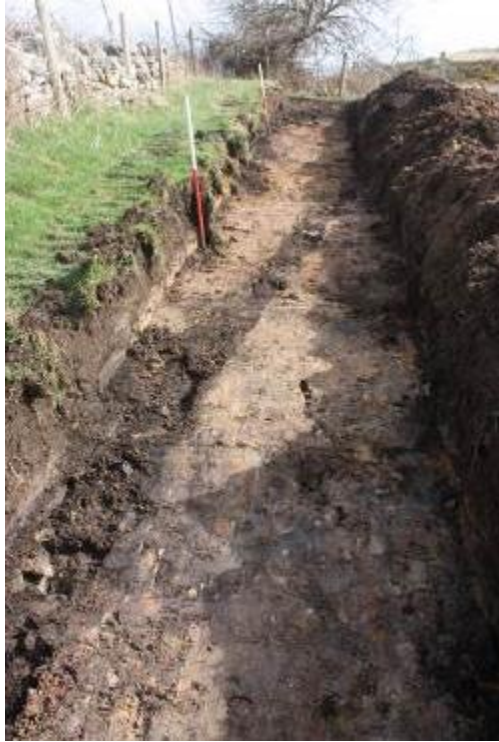
Figure 23 Looking east to field 6.

Field 6: This field consists of flat reclaimed grazing land although the stratigraphy below the sod was similar to the previously described fields. The trench was 50m long and was excavated to a depth of 0.6m. The sod and topsoil was 0.2m thick and consisted of mid grey silt which rested on 0.4m of dark peat with frequent rubble inclusions in the eastern half. The subsoil was a continuation of the boulderclay present elsewhere. The modern pipe trench continued through the eastern half of this field and was cut to a depth of 0.3m into the subsoil. No other finds or features were present.

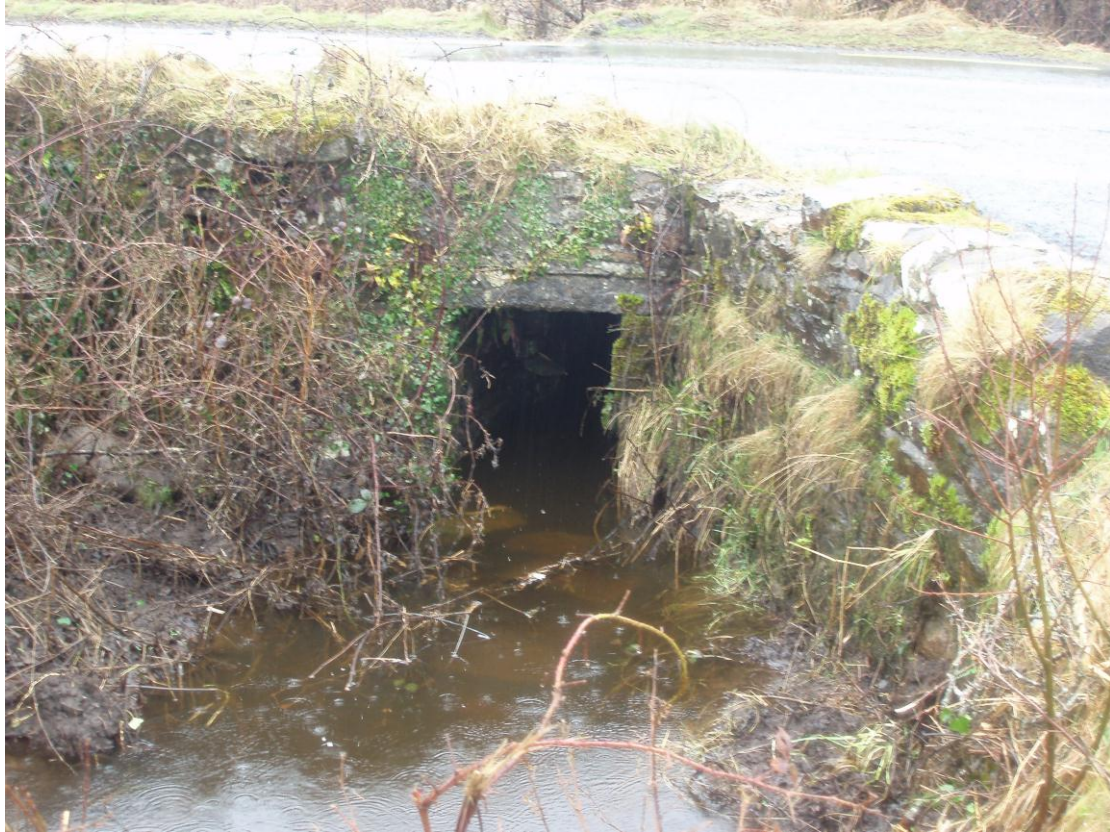
Figure 24 Current bridge / culvert

The existing road spans a river between fields 4 and 5 and it is planned to reroute this river via a culvert to the west of the existing river and remove the existing bridge/culvert. It is recommended that works on the existing bridge/culvert be archaeologically monitored to identify and record any potential early features that may be exposed. It is planned for these works to be monitored by the writer and if anything of archaeological significance is uncovered further mitigation shall be carried out upon consultation with the national monuments service.
