Building refurbishment – Gründerzeit houses

Refurbishment of Gründerzeit houses

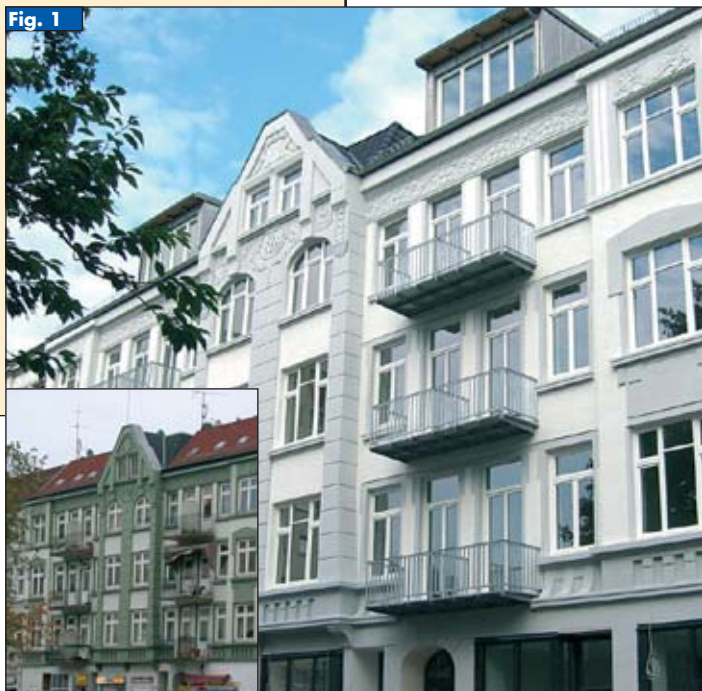
Fig. 1

The mirror-image building halves before and after refurbishment, left building half: standard building – refurbished according to Hamburg's climate protection programme, right building half: EnSan building

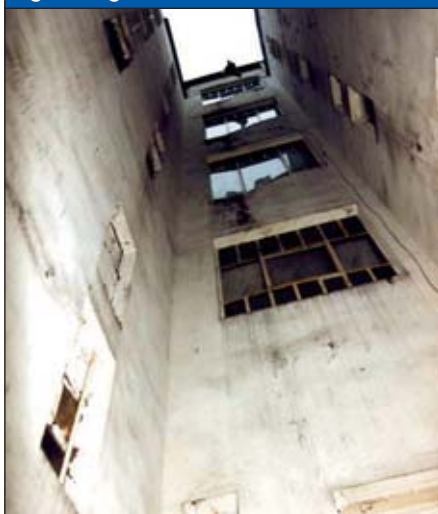
Fig. 3: Light shaft before refurbishment

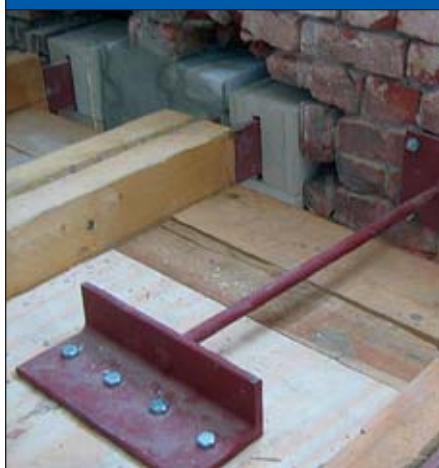
Fig. 7: This view shows refurbished beam heads with steel bracing and the connection to the exterior wall with tension anchor..

One focal area in the EnSan project was the refurbishment of the wooden beam ceilings and their integration with the exterior walls. The front facade of the EnSan building was insulated on the inside with calcium silicate panels, which meant that the beam heads would form a thermal bridge. Condensation on the beam heads, combined with the prevalent temperatures in the flats, could have resulted in ideal conditions for growth of harmful fungi. The newly developed beam head structure prevents direct contact between the wood and the masonry, in that the ceiling beams are extended by an insulated flat steel bracing in the area of the wall connection. This thermal isolation solution can be implemented regardless of the thickness of the ceiling beams (fig. 7).

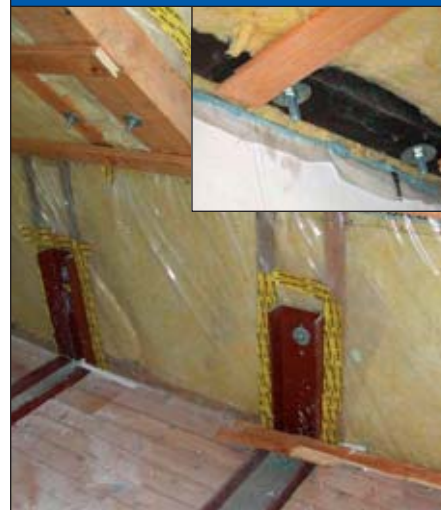
Fig. 8: Air sealing of the ceiling and dormer wall
